Technical Assessment

Path Maintenance and Improvement Works to Castle Loch Walk, Lochmaben

Paths for All Partnership
Kintail House,
Forthside Way,
Stirling, FK8 1QZ

Produced on: January 2020

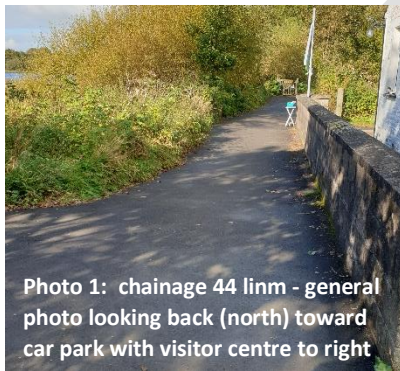
Photo 1: chainage 44 linm - general photo looking back (north) toward car park with visitor centre to right					
44 – 165	↔	/	0.6	Access road ends at 44 linm and aggregate path begins. General photo looking back toward car park.

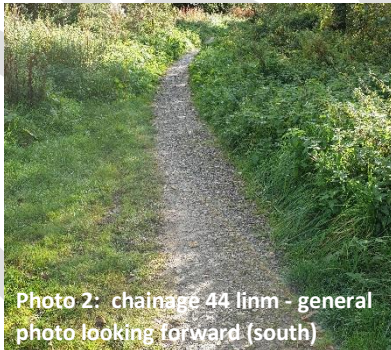
Photo 2: chainage 44 linm - general photo looking forward (south) Route clearly defined with surface composed of compacted Type 1 aggregate to approx. 600mm width and with encroaching verges which have narrowed finished path width over time.					
Chainage (linm)	Slope Dir	Grad. (%/deg)	Width (m)	Current Path Condition		Description of Proposed Path Works

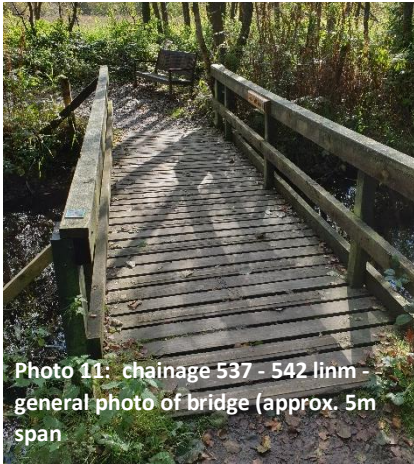
<p>Photo 11: chainage 537 - 542 linm - general photo of bridge (approx. 5m span)</p></div> <p>General photo taken looking forward to timber bridge (1400mm wide with parapets at 840mm height). Path continues through shaded woodland area. Path surface remains composed of compacted Type 1 aggregate.</p>			<p>Vegetation Management: Clear any overhanging vegetation, along length of route, to a height of not less than 3.5m from finished path surface (preferred height 3.7m) and any smaller encroaching vegetation not less than 1m from path edges and to a height of 50mm, unless otherwise noted within this technical assessment. All woody vegetation to be cut into manageable lengths and distributed across site within agreed locations.</p> <p>Barriers/Other features: Incorporate bridge condition inspection and seat cleaning into annual maintenance schedule. Remove all vegetation growing on or adjacent to bridge structure. Uphill path surface approaches to bridge to remove any stepped level variances.</p> <p>Path construction and surfacing: Option 1: Carefully scrape back all encroaching verge vegetation to expose full width of previously installed path (estimated to be a minimum of 1.5m) and upgrade surface to Drawing CL/UPU/CLLCT/001. Construct path levels to max 1:40 camber throughout to allow any surface water run-off to be discharged off the path and into verge area on either side. All verge scrape arisings to be utilised to reform path verges, ensuring finished verge levels remain below path surface levels to allow surface water run-off.</p> <p>Option 2: Assumes no upgrade works, as detailed within Option 1. Maintain usable path surface width by regularly cutting back verge vegetation to a width of 1m on either side. Consideration to be given to undertaking a phased programme of maintenance works aimed at carefully scraping back existing verge to expose original path width. Alternative is to apply appropriate herbicide to encroaching ground vegetation and to a width not exceeding original path base width (requires PA1/PA6a certification). Occasional compaction of surface.</p> <p>Drainage: For path construction options 1 and 2: Install drainage letts along the verge to better enable surface water run-off and to alleviate any possible ponding along the edges of the path surface. Locate as required and to a min width of 200mm.</p> <p>Signage: No works required.</p>

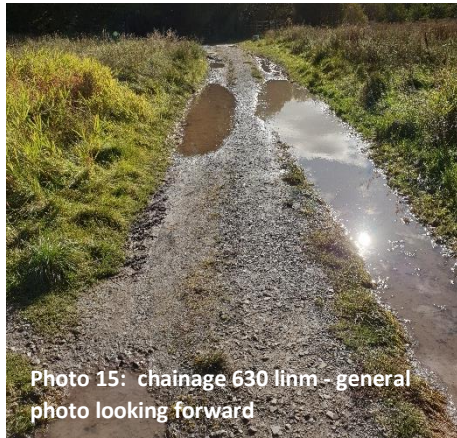
<p>Photo 15: chainage 630 linm - general photo looking forward</p> <p>General photo taken looking forward and showing notable puddles formed in wheel ruts on track.</p>					
630	/	/	/						
630 - 660	↔	/	3.0						
660	/	/	/	<p>Route continues along line of farm track.</p>

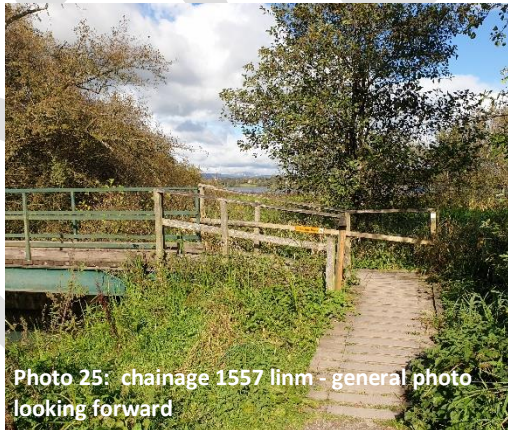
</div> <p>General photo showing where path meets timber ramp leading up to bridge over Valison Burn. Ramp decking has aftermarket anti-slip strips applied. Gradient not measured.</p>		<p>Option 2: Assumes no upgrade works, as detailed within Option 1. Maintain usable path surface width by regularly cutting back verge vegetation to a width of 1m on either side. Consideration to be given to undertaking a phased programme of maintenance works aimed at carefully scraping back existing verge to expose original path width. Alternative is to apply appropriate herbicide to encroaching ground vegetation and to a width not exceeding original path base width (requires PA1/PA6a certification). Occasional compaction of surface.</p> <p>Drainage: For path construction options 1 and 2: Install drainage letts along the verge to better enable surface water run-off and to alleviate any possible ponding along the edges of the path surface. Locate as required and to a min width of 200mm.</p> <p>Signage: No works required.</p>

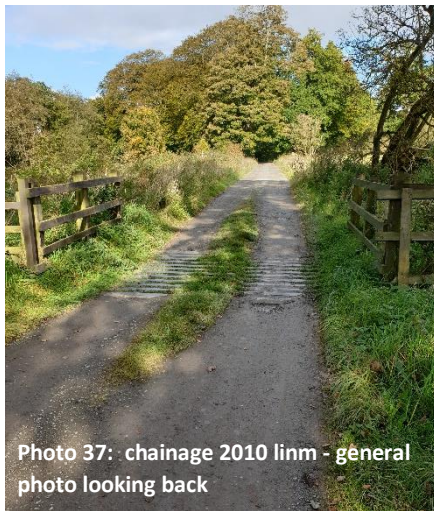
</div> <p>Photo 37: chainage 2010 linm - general photo looking back</p> <p>General photo showing Lochmaben Castle access road and cattle grid which was largely infilled with silt/debris at the time of survey.</p>			<p>Vegetation Management: Clear any overhanging vegetation, along length of route, to a height of not less than 3.5m from track surface (preferred height 3.7m). All woody vegetation to be cut into manageable lengths and distributed within site within agreed locations.</p> <p>Barriers/Other features: No works required.</p> <p>Path construction and surfacing: Consider filling in of cattle grid to remove obstacle. If this is not possible, consideration might be given to establish a surfaced and gated by-pass to left as viewed on photo</p> <p>Drainage: No works required.</p> <p>Signage: Incorporate sign condition inspection and clearance of ground vegetation around post base into annual maintenance schedule.</p>

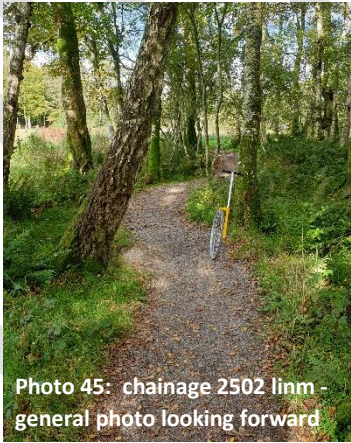
<p>Photo 45: chainage 2502 linm - general photo looking forward</p> <p>General photo showing birch tree leaning over into open route corridor at chainage 2502 linm.</p>					
Chainage (linm)	Slope Dir	Grad. (%/deg)	Width (m)	Current Path Condition			Description of Proposed Path Works

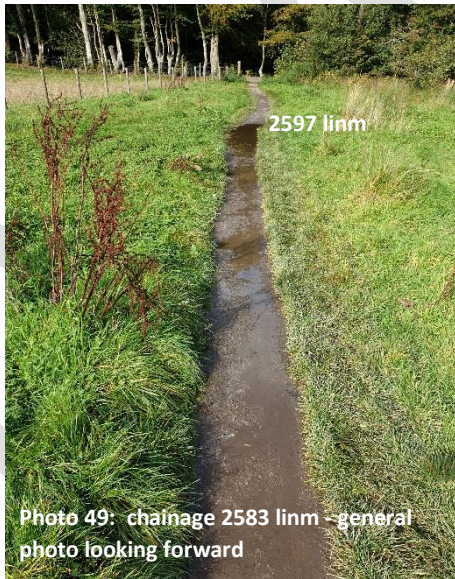
<p>Photo 49: chainage 2583 linm - general photo looking forward</p> <p>General photo looking forward and showing water retention between chainage 2583 and 2597 linm. Path surface remains as compacted aggregate with verges built higher than path surface and little opportunity for surface water to get off path.</p>						
Chainage (linm)	Slope Dir	Grad. (%/deg)	Width (m)	Current Path Condition					Description of Proposed Path Works

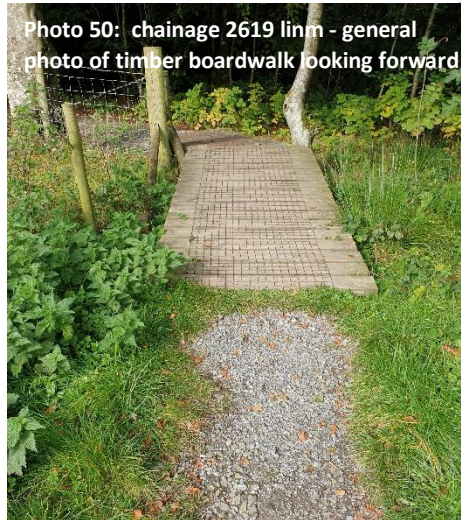
</div> <p>General photo looking forward showing short section of 'humped' boardwalk that elevates route over wet section of ground at corner of adjacent land.</p>					
2619 - 2625	↔	/	1.2	Wooden boardwalk section. 1.2m wide with steel mesh applied as anti-slip measure. Stepped transitions between boardwalk and aggregate path where aggregate has worn away.

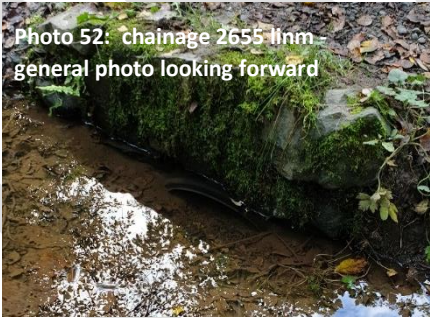
<p>Photo 52: chainage 2655 linm - general photo looking forward</p> <p>General photo showing twin wall piped culvert taking water from left to right under path. Culvert almost totally blocked with silt and leaf litter but some very limited flow still remains and stops water overflowing onto path.</p>					
Chainage (linm)	Slope Dir	Grad. (%/deg)	Width (m)	Current Path Condition		Description of Proposed Path Works

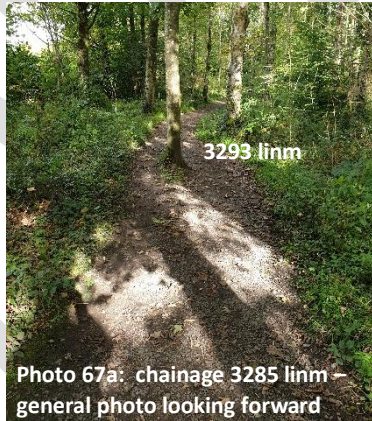
</div> <p>Photo 67a: chainage 3285 linm – general photo looking forward</p> <p>General photo looking forward and showing tree situated in middle of path at chainage 3293. Route widens at this point at users circumvent the tree.</p>							
Chainage (linm)	Slope Dir	Grad. (%/deg)	Width (m)	Current Path Condition				Description of Proposed Path Works
