Technical Assessment

Path Maintenance and Improvement Works to Castle Loch Walk, Lochmaben

Paths for All Partnership
Kintail House,
Forthside Way,
Stirling, FK8 1QZ

Produced on: January 2020

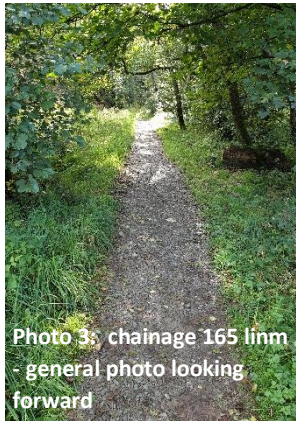
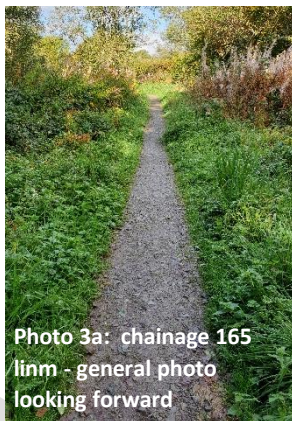
</div> <p>Photo 3: chainage 165 linm - general photo looking forward</p> <p>Photo 3a: chainage 165 linm - general photo looking forward</p> <p>General photos at Chainage 165linm. Path remains well defined and formed from compacted Type 1 aggregate.</p>		<p>Vegetation Management:</p> <p>Clear any overhanging vegetation, along length of route, to a height of not less than 3.5m from finished path surface (preferred height 3.7m) and any smaller encroaching vegetation not less than 1m from path edges and to a height of 50mm, unless otherwise noted within this technical assessment.</p> <p>All woody vegetation to be cut into manageable lengths and distributed across site within agreed locations.</p> <p>Barriers/Other features:</p> <p>No works required.</p> <p>Path construction and surfacing:</p> <p>Option 1: Carefully scrape back all encroaching verge vegetation to expose full width of previously installed path (estimated to be a minimum of 1.5m) and upgrade surface to Drawing CL/UPU/CLLCT/001. Construct path levels to max 1:40 camber throughout to allow any surface water run-off to be discharged off the path and into verge area on either side. All verge scrape arisings to be utilised to reform path verges, ensuring finished verge levels remain below path surface levels to allow surface water run-off.</p> <p>Option 2: Assumes no upgrade works, as detailed within Option 1. Maintain usable path surface width by regularly cutting back verge vegetation to a width of 1m on either side. Consideration to be given to undertaking a phased programme of maintenance works aimed at carefully scraping back existing verge to expose original path width. Alternative is to apply appropriate herbicide to encroaching ground vegetation and to a width not exceeding original path base width (requires PA1/PA6a certification). Occasional compaction of surface.</p> <p>Drainage:</p> <p>For path construction options 1 and 2: Install drainage letts along the verge to better enable surface water run-off and to alleviate any possible ponding along the edges of the path surface. Locate as required and to a min width of 200mm.</p> <p>Signage:</p> <p>Incorporate sign cleaning into annual maintenance schedule.</p>

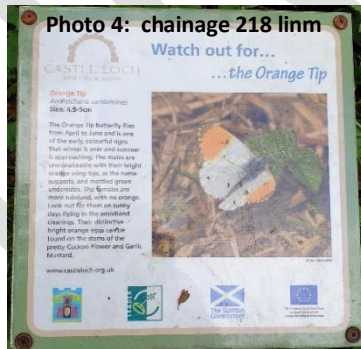
</div> <p>Photo 4: chainage 218 linm</p> <p>General photo of environmental interpretation to right of path.</p>					
Chainage (linm)	Slope Dir	Grad. (%/deg)	Width (m)	Current Path Condition		Description of Proposed Path Works

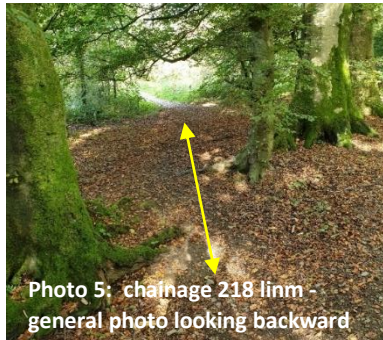
Path Survey and Specification Sheet								Sheet No.	3
Location:		Castle Loch, Lochmaben, Dumfries and Galloway				Weather:	Dry, sunny intervals	Surveyor:	G Anderson
Path:		Castle Loch Circular Route				Date:	05.10.20	Section:	Chainage (218 – 388 linm)
218 - 260	↔	/	<1.0m	<p>Path remains reasonably well defined and widens due to reduced vegetation growth under tree canopy (see Photo 5). Surface composed of leaf litter over Type 1 surfaced path.</p> <div>

<p>Photo 5: chainage 218 linm - general photo looking backward</p></div> <p>General photo of desire line shortcut looking back.</p>					
260	/	/	/						
260 - 388	↔	/	<1.0m	<p>Path remains well defined but narrow slightly to 1.0m.</p> <div>

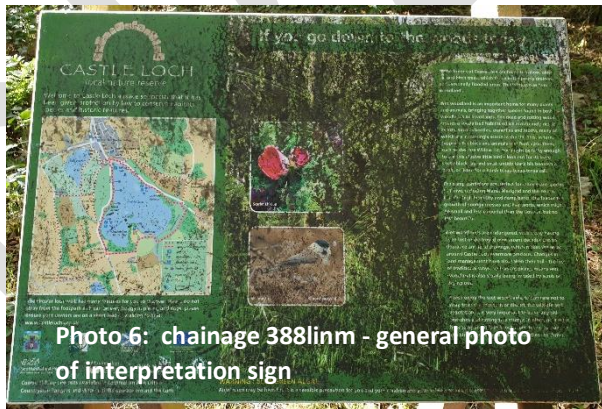
<p>Photo 6: chainage 388linm - general photo of interpretation sign</p></div> <p>General photo of environmental interpretation to right of path.</p>					
388	/	/	/						
Chainage (linm)	Slope Dir	Grad. (%/deg)	Width (m)	Current Path Condition				Description of Proposed Path Works

<p>Vegetation Management: Clear any overhanging vegetation, along length of route, to a height of not less than 3.5m from finished path surface (preferred height 3.7m) and any smaller encroaching vegetation not less than 1m from path edges and to a height of 50mm, unless otherwise noted within this technical assessment. All woody vegetation to be cut into manageable lengths and distributed across site within agreed locations.</p> <p>Barriers/Other features: No works required.</p> <p>Path construction and surfacing: Option 1: Carefully scrape back all encroaching verge vegetation to expose full width of previously installed path (estimated to be a minimum of 1.5m) and upgrade surface to Drawing CL/UPU/CLLCT/001. Construct path levels to max 1:40 camber throughout to allow any surface water run-off to be discharged off the path and into verge area on either side. All verge scrape arisings to be utilised to reform path verges, ensuring finished verge levels remain below path surface levels to allow surface water run-off.</p> <p>Option 2: Assumes no upgrade works, as detailed within Option 1. Maintain usable path surface width by regularly cutting back verge vegetation to a width of 1m on either side. Consideration to be given to undertaking a phased programme of maintenance works aimed at carefully scraping back existing verge to expose original path width. Alternative is to apply appropriate herbicide to encroaching ground vegetation and to a width not exceeding original path base width (requires PA1/PA6a certification). Occasional compaction of surface.</p> <p>Option 3: Consider constructing new path (to Drawing CL/UPHT/CLLCT/002) to formalise desire line. Care to be taken to avoid root damage when passing through beech tree (estimated 30linm).</p> <p>Drainage: For path construction options 1 and 2: Install drainage letts along the verge to better enable surface water run-off and to alleviate any possible ponding along the edges of the path surface. Locate as required and to a min width of 200mm.</p> <p>Signage: Incorporate sign cleaning into annual maintenance schedule.</p>

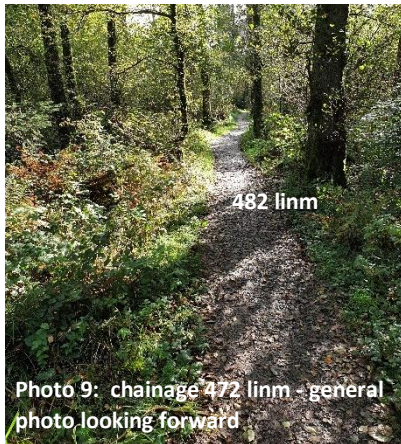
</div> <p>482 linm</p> <p>Photo 9: chainage 472 linm - general photo looking forward</p> <p>Path continues through shaded woodland area. Path surface remains composed of compacted Type 1 aggregate. Small puddle formed at chainage 482 linm. No side drainage present and limited option for water to get off path.</p>			<p>Vegetation Management: Clear any overhanging vegetation, along length of route, to a height of not less than 3.5m from finished path surface (preferred height 3.7m) and any smaller encroaching vegetation not less than 1m from path edges and to a height of 50mm, unless otherwise noted within this technical assessment. All woody vegetation to be cut into manageable lengths and distributed across site within agreed locations.</p> <p>Barriers/Other features: No works required.</p> <p>Path construction and surfacing: Option 1: Carefully scrape back all encroaching verge vegetation to expose full width of previously installed path (estimated to be a minimum of 1.5m) and upgrade surface to Drawing CL/UPU/CLLCT/001. Construct path levels to max 1:40 camber throughout to allow any surface water run-off to be discharged off the path and into verge area on either side. All verge scrape arisings to be utilised to reform path verges, ensuring finished verge levels remain below path surface levels to allow surface water run-off.</p> <p>Option 2: Assumes no upgrade works, as detailed within Option 1. Maintain usable path surface width by regularly cutting back verge vegetation to a width of 1m on either side. Consideration to be given to undertaking a phased programme of maintenance works aimed at carefully scraping back existing verge to expose original path width. Alternative is to apply appropriate herbicide to encroaching ground vegetation and to a width not exceeding original path base width (requires PA1/PA6a certification). Occasional compaction of surface.</p> <p>Drainage: For path construction options 1 and 2: Install drainage letts along the verge to better enable surface water run-off and to alleviate any possible ponding along the edges of the path surface. Locate as required and to a min width of 200mm.</p> <p>Signage: Incorporate sign cleaning into annual maintenance schedule.</p>

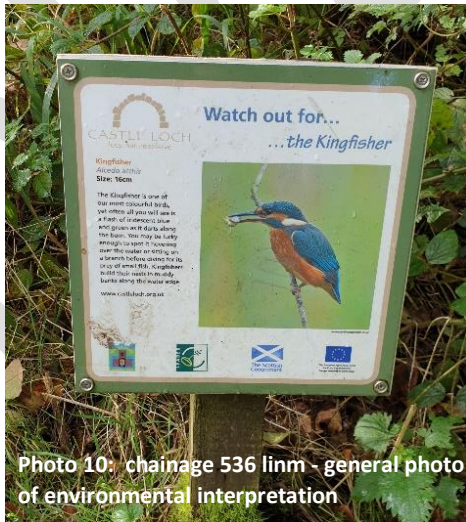
</div> <p>Photo 10: chainage 536 linm - general photo of environmental interpretation</p> <p>General photo of environmental interpretation to right of path.</p>					
Chainage (linm)	Slope Dir	Grad. (%/deg)	Width (m)	Current Path Condition				Description of Proposed Path Works

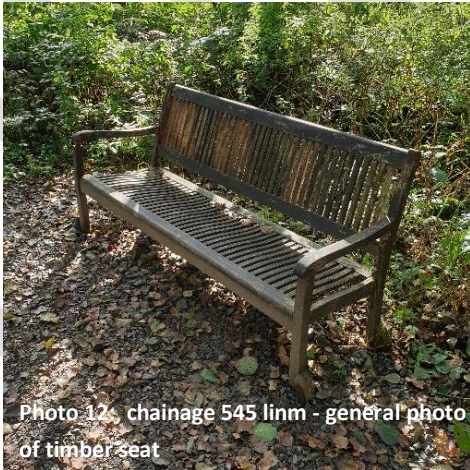
<p>Photo 12: chainage 545 linm - general photo of timber seat</p></div> <p>General photo of timber bench.</p>					
Chainage (linm)	Slope Dir	Grad. (%/deg)	Width (m)	Current Path Condition			Description of Proposed Path Works

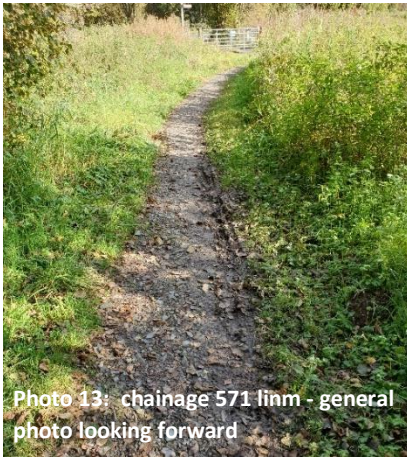
Photo 13: chainage 571 linm - general photo looking forward General photo taken looking forward and toward muddy section of path between chainages 571 – 574 linm. Path surface generally composed of compacted Type 1 aggregate. Build-up of verge levels are limiting any surface water run-off.					
591	/	/	/

Vegetation Management:
 Clear any overhanging vegetation, along length of route, to a height of not less than 3.5m from finished path surface (preferred height 3.7m) and any smaller encroaching vegetation not less than 1m from path edges and to a height of 50mm, unless otherwise noted within this technical assessment.
 All woody vegetation to be cut into manageable lengths and distributed across site within agreed locations.

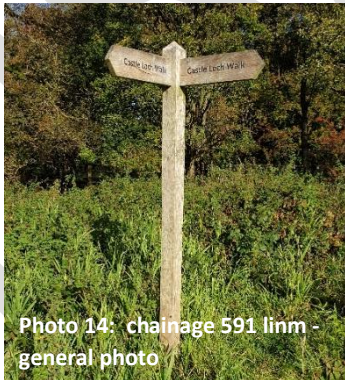
Photo 14: chainage 591 linm - general photo General photo of timber fingerpost at chainage 591 linm.					
Chainage (linm)	Slope Dir	Grad. (%/deg)	Width (m)	Current Path Condition		Description of Proposed Path Works

Signage:
 Incorporate sign condition inspection and clearance of ground vegetation around post base into annual maintenance schedule.

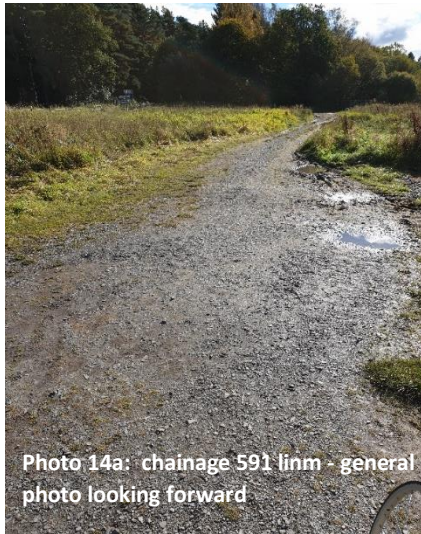
<p>Photo 14a: chainage 591 linm - general photo looking forward</p></div> <p>General photo taken looking forward along route as it drops down gentle gradient toward Board Burn.</p>	<p>Vegetation Management: Clear encroaching vegetation not less than 1m from finished track edges and to a height of 50mm, unless otherwise noted within this technical assessment. Maintain all vegetation around 1-way opening gate to ensure easy opening at all times.</p> <p>Barriers/Other features: Maintain gate in a good and safe working order.</p> <p>Path construction and surfacing: Option 1: Infill potholes and/or wheel ruts to maintain a reasonably dry and level walking/wheeling surface along this section of the circular route. Additional consideration to be given to surfacing short link path through side gate and back onto farm track (estimated at 5 linm)</p> <p>Drainage: Install drainage letts along the verge to better enable surface water run-off and to alleviate any possible ponding along the track surface. Locate as required and to a min width of 200mm.</p> <p>Signage: Incorporate sign condition inspection and clearance of ground vegetation around post base into annual maintenance schedule.</p>

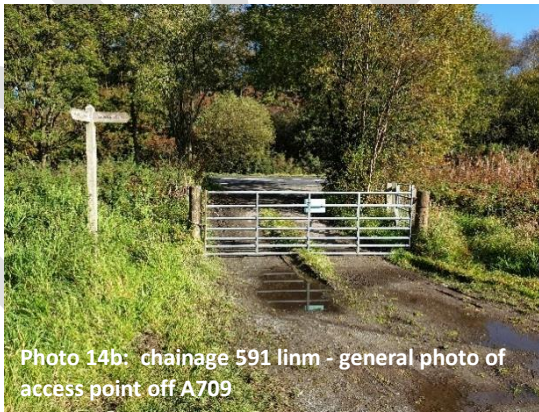
<p>Photo 14b: chainage 591 linm - general photo of access point off A709</p></div> <p>General photo taken looking north and showing pedestrian gate to right of field gate.</p>					
Chainage (linm)	Slope Dir	Grad. (%/deg)	Width (m)	Current Path Condition		Description of Proposed Path Works

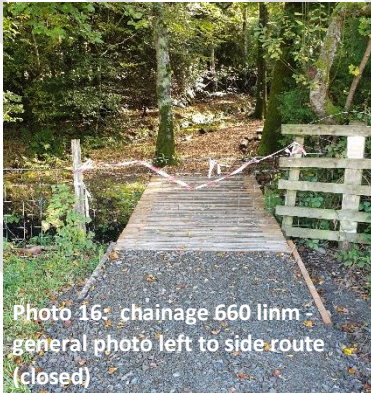
<p>Photo 16: chainage 660 linm - general photo left to side route (closed)</p> <p>General photo taken looking to left of track and showing woodland path (closed at time of survey).</p>

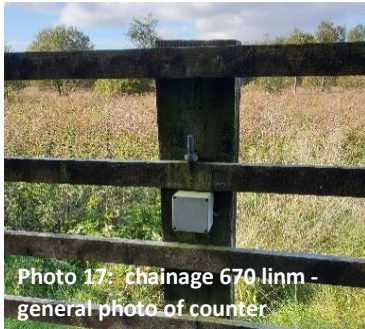
</div> <p>Photo 17: chainage 670 linm - general photo of counter</p> <p>General photo taken at chainage 670 linm of counter mechanism on post and rail fence post to right of track. Not known if operational.</p>					
670	/	/	/						
670 - 685	↔	/	3.0	<p>Route continues along line of farm track. Track in generally good condition with isolated puddles in ruts along outer edges.</p> <div>

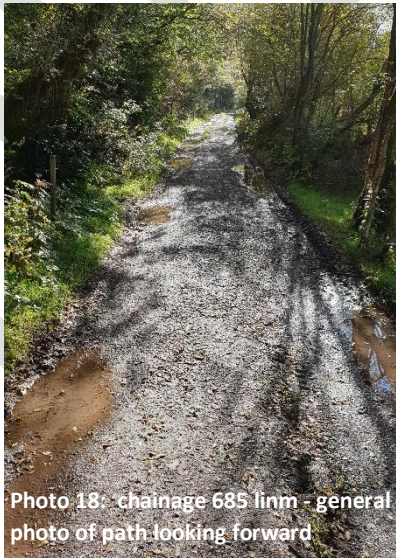
</div> <p>Photo 18: chainage 685 linm - general photo of path looking forward</p> <p>General photo taken looking forward.</p>					
685	/	/	/						
Chainage (linm)	Slope Dir	Grad. (%/deg)	Width (m)	Current Path Condition				Description of Proposed Path Works

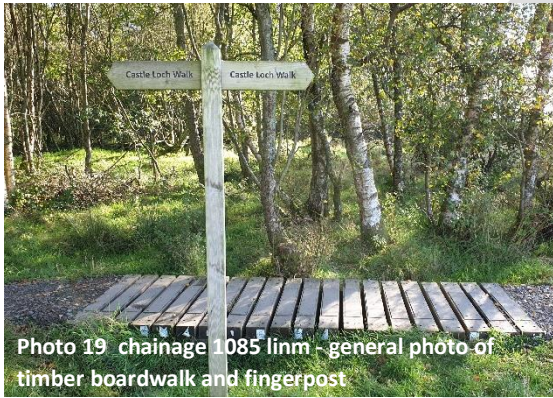
<p>Photo 19 chainage 1085 linm - general photo of timber boardwalk and fingerpost</p></div> <p>General photo showing southern end of woodland path noted at chainage 660 linm.</p> <div>

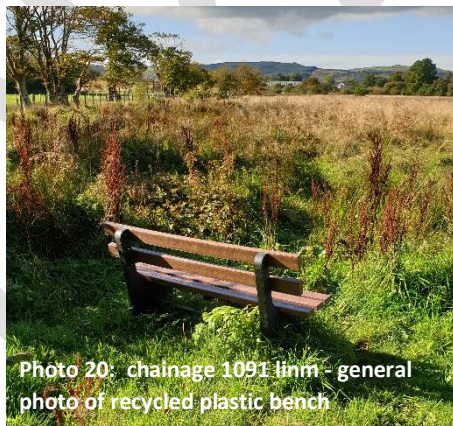
<p>Photo 20: chainage 1091 linm - general photo of recycled plastic bench</p></div> <p>General photo showing recycled plastic bench facing west.</p>					
1085	/	/	/						
1085 - 1091	/	/	/						
1091 - 1100	/	/	3.0						
Chainage (linm)	Slope Dir	Grad. (%/deg)	Width (m)	Current Path Condition				Description of Proposed Path Works

<p>Vegetation Management: Clear any overhanging vegetation, along length of route, to a height of not less than 3.5m from finished path surface (preferred height 3.7m) and any smaller encroaching vegetation not less than 1m from path edges and to a height of 50mm, unless otherwise noted within this technical assessment. All woody vegetation to be cut into manageable lengths and distributed across site within agreed locations.</p> <p>Barriers/Other features: Incorporate seat cleaning into annual maintenance schedule. Regularly cut all vegetation growing around and under bench seat. Option: install Type 1/whin dust hardstanding under seating area and to form link path to farm track.</p> <p>Path construction and surfacing: Option 1: Infill potholes and/or wheel ruts to maintain a reasonably dry and level walking/wheeling surface along this section of the circular route.</p> <p>Drainage: Install drainage letts along the verge to better enable surface water run-off and to alleviate any possible ponding along the track surface. Locate as required and to a min width of 200mm</p> <p>Signage: Incorporate sign condition inspection and clearance of ground vegetation around post base into annual maintenance schedule.</p>

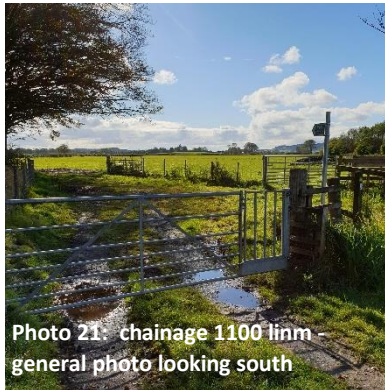
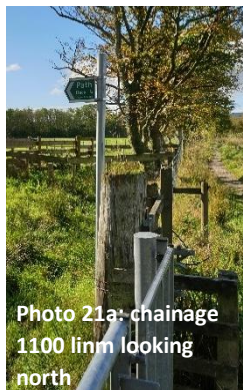
</div> <p>Photo 21: chainage 1100 linm - general photo looking south</p> <p>Photo 21a: chainage 1100 linm looking north</p> <p>General photo showing path junction where Core Path 306 continues west through side pedestrian gate to 'Heck' and the Castle Loch Path turns off farm track heading north.</p>	<p>Vegetation Management: Clear any overhanging vegetation, along length of route, to a height of not less than 3.5m from finished path surface (preferred height 3.7m) and any smaller encroaching vegetation not less than 1m from path edges and to a height of 50mm, unless otherwise noted within this technical assessment. All woody vegetation to be cut into manageable lengths and distributed across site within agreed locations.</p> <p>Barriers/Other features: Maintain gate in a good and safe working order.</p> <p>Path construction and surfacing: Option 1: Infill potholes and/or wheel ruts to maintain a reasonably dry and level walking/wheeling surface along this section of the circular route. Additional consideration to be given to surfacing short link path through side gate and back onto farm track (estimated at 5 linm)</p> <p>Drainage: Install drainage letts along the verge to better enable surface water run-off and to alleviate any possible ponding along the track surface. Locate as required and to a min width of 200mm</p> <p>Signage: Incorporate sign condition inspection and clearance of ground vegetation around post base into annual maintenance schedule.</p>

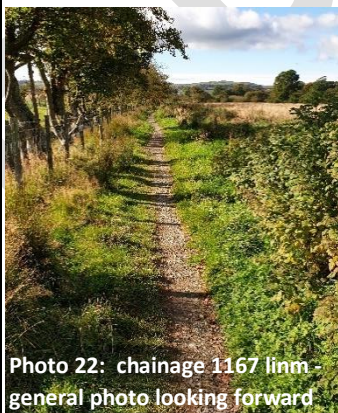
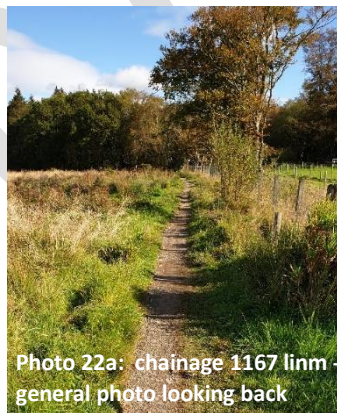
1100 - 1167	↔	/	0.4	Route turns off farm track to north and follows field edge to left. Path surface returns to compacted Type 1 aggregate and narrows to approx. 0.3 – 0.4m width with encroaching grass verges					
1167	/	/	/	<div>

</div> <p>Photo 22: chainage 1167 linm - general photo looking forward</p> <p>Photo 22a: chainage 1167 linm - general photo looking back</p> <p>General photos looking forward (north) and back (south) along path; showing narrowed surface width and exposed aggregate surface.</p>					
Chainage (linm)	Slope Dir	Grad. (%/deg)	Width (m)	Current Path Condition		Description of Proposed Path Works

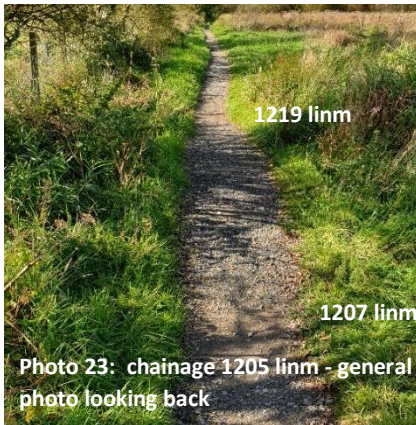
<p>Photo 23: chainage 1205 linm - general photo looking back</p><p>General photo taken looking forward and showing limited widening of path width to 1.0m between chainage 1207 and 1219 linm. Surface slightly more exposed at this section, possible due to water dripping off overhanging branches.</p></div>					
1205	/	/	/						
1205 - 1473	↔	/	0.4	<p>Path continues north along field edge with unchanged surface composition. Width narrows back to 0.4m from chainage 1219 linm. Path undulates (3no.) between chainages 1382 – 1403 linm.</p> <div>

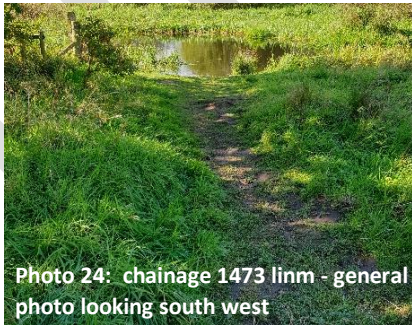
<p>Photo 24: chainage 1473 linm - general photo looking south west</p><p>Photo showing short 12 linm unsurfaced path that turns left off main route and ends at bank of Valison Burn</p></div>

1473	/	/	/						
Chainage (linm)	Slope Dir	Grad. (%/deg)	Width (m)	Current Path Condition				Description of Proposed Path Works	
<p>Vegetation Management: Clear any overhanging vegetation, along length of route, to a height of not less than 3.5m from finished path surface (preferred height 3.7m) and any smaller encroaching vegetation not less than 1m from path edges and to a height of 50mm, unless otherwise noted within this technical assessment. All woody vegetation to be cut into manageable lengths and distributed across site within agreed locations.</p> <p>Barriers/Other features: No works required.</p> <p>Path construction and surfacing: Option 1: Carefully scrape back all encroaching verge vegetation to expose full width of previously installed path (estimated to be a minimum of 1.5m) and upgrade surface to Drawing CL/UPU/CLLCT/001. Construct path levels to max 1:40 camber throughout to allow any surface water run-off to be discharged off the path and into verge area on either side. All verge scrape arisings to be utilised to reform path verges, ensuring finished verge levels remain below path surface levels to allow surface water run-off. Option 2: Assumes no upgrade works, as detailed within Option 1. Maintain usable path surface width by regularly cutting back verge vegetation to a width of 1m on either side. Consideration to be given to undertaking a phased programme of maintenance works aimed at carefully scraping back existing verge to expose original path width. Alternative is to apply appropriate herbicide to encroaching ground vegetation and to a width not exceeding original path base width (requires PA1/PA6a certification). Occasional compaction of surface.</p> <p>Drainage: For path construction options 1 and 2: Install drainage letts along the verge to better enable surface water run-off and to alleviate any possible ponding along the edges of the path surface. Locate as required and to a min width of 200mm.</p> <p>Signage: No works required.</p>

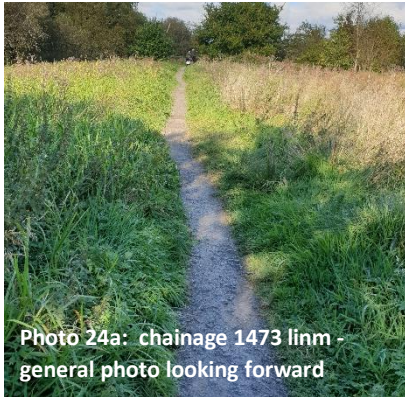
</div> <p>General photo taken looking forward</p>		<p>Vegetation Management: Clear any overhanging vegetation, along length of route, to a height of not less than 3.5m from finished path surface (preferred height 3.7m) and any smaller encroaching vegetation not less than 1m from path edges and to a height of 50mm, unless otherwise noted within this technical assessment. All woody vegetation to be cut into manageable lengths and distributed across site within agreed locations.</p> <p>Barriers/Other features: Incorporate bridge and ramp condition inspection into annual maintenance schedule. Remove all vegetation growing on or adjacent to bridge structure and access ramps. Uphill path surface approaches to bridge to remove any stepped level variances. Option: to replace full structure to enhance accessibility (typically 1.5m width with reduced access ramps)</p>

1473 - 1557	↔	/	0.3	Path continues north along eastern side of Valison Burn with slightly narrowed surface width and unchanged surface composition of compacted aggregate. Timber bench located to right of path (east) at chainage 1529 linm.		<p>Path construction and surfacing: Option 1: Carefully scrape back all encroaching verge vegetation to expose full width of previously installed path (estimated to be a minimum of 1.5m) and upgrade surface to Drawing CL/UPU/CLLCT/001. Construct path levels to max 1:40 camber throughout to allow any surface water run-off to be discharged off the path and into verge area on either side. All verge scrape arisings to be utilised to reform path verges, ensuring finished verge levels remain below path surface levels to allow surface water run-off.</p>			
1557 - 1565	↑	/	/	<div>

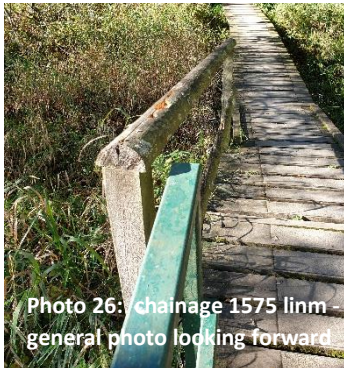
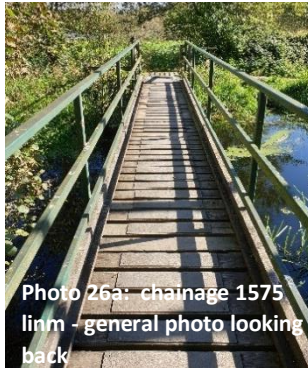
<p>General photos showing bridge over Valison Burn (note: sign attached to bridge states “Vallison Burn”). Bridge measured at 1000mm wide, metal parapets at 1120 height, decking gaps at 40mm. Bridge in generally reasonable condition but not subjected to a thorough inspection.</p>	<p>Vegetation Management: Clear any overhanging vegetation, along length of route, to a height of not less than 3.5m from finished deck surface (preferred height 3.7m) and any smaller encroaching vegetation not less than 1m from boardwalk edges, unless otherwise noted within this technical assessment. All woody vegetation to be cut into manageable lengths and distributed across site within agreed locations.</p> <p>Barriers/Other features: Incorporate bridge and ramp condition inspection into annual maintenance schedule. Remove all vegetation growing on or adjacent to bridge structure and access ramps. Uphill path surface approaches to bridge to remove any stepped level variances. Option: to replace full structure to enhance accessibility (typically 1.5m width with reduced access ramps)</p> <p>Path construction and surfacing: Boardwalk: Remove existing raised walkway and replace with new; to a width not less than 1600mm and to Drawing No. CL/LLW/CLLCT/002. Construct new raised walkway at a finished height greater than existing and to accommodate maximum anticipated water levels (to be agreed). Consideration to be given to incorporating regular passing places (not exceeding 50m apart) along route of raised walkway. Passing places to be constructed to general detail shown within Drawing No. CL/LLW/CLLCT/002 Detail C.</p> <p>Drainage: No works required.</p> <p>Signage: No works required.</p>

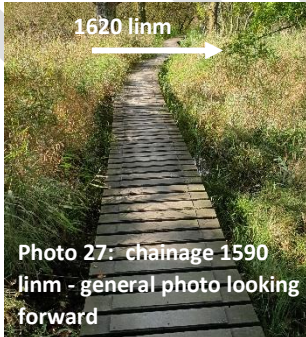
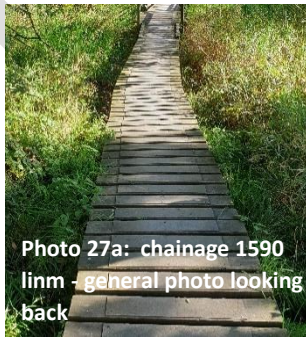
1575 - 1578	↓	/	1.0	Short timber ramp leading down from bridge to start of boardwalk. Decking timbers have aftermarket anti-slip strips applied. Gradient not measured.					
1578 - 1590	↔	/	1.0	Timber boardwalk with 660mm wide aftermarket anti-slip strips applied to decking. Boardwalk structure and decking (150 x 50mm boards) remains sound. No edge rails to decking and gaps between decking boards measured at 35 – 40mm.					
1590	/	/	/

<p>General photo looking forward & back along boardwalk, showing location of side link to bird hide (chainage 1620 linm)</p>					
Chainage (linm)	Slope Dir	Grad. (%/deg)	Width (m)	Current Path Condition	Description of Proposed Path Works

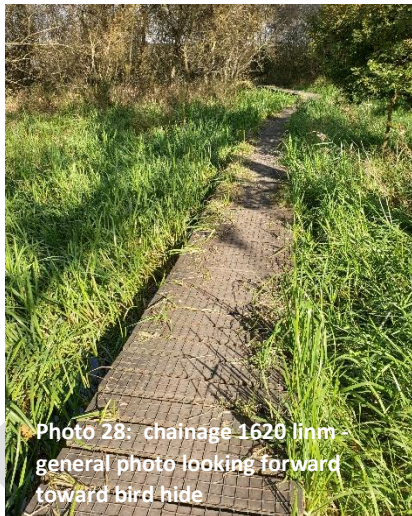
<p>Photo 28: chainage 1620 linm - general photo looking forward toward bird hide</p></div> <p>Boardwalk splits with a side branch to right leading to bird hide. This section measures approx. 48 linm and ramps upward to end at bird hide which sits 900mm above water level at time of survey. Boardwalk decking is covered with steel mesh (see photo 30), as an anti-slip measure, over first 23 linm and then changes to aftermarket anti-slip strips as noted before. These are applied in a ‘hit and miss’ manner.</p>

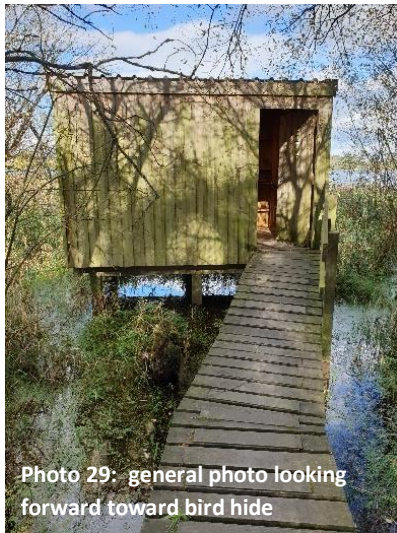
<p>Photo 29: general photo looking forward toward bird hide</p></div> <p>General photo of bird hide looking forward and noting short ramp up to entrance plus 'hit and miss' anti-slip strips applied to alternate decking boards.</p>	<p>Vegetation Management: Clear any overhanging vegetation, along length of route, to a height of not less than 3.5m from finished deck surface (preferred height 3.7m) and any smaller encroaching vegetation not less than 1m from boardwalk edges, unless otherwise noted within this technical assessment. All woody vegetation to be cut into manageable lengths and distributed across site within agreed locations.</p> <p>Barriers/Other features: Structure and ongoing maintenance of bird hide not included within the scope of this study.</p> <p>Path construction and surfacing: Boardwalk: Remove existing raised walkway and replace with new; to a width not less than 1600mm and to Drawing No. CL/LLW/CLLCT/002. Construct new raised walkway at a finished height greater than existing and to accommodate maximum anticipated water levels (to be agreed). Consideration to be given to incorporating regular passing places (not exceeding 50m apart) along route of raised walkway. Passing places to be constructed to general detail shown within Drawing No. CL/LLW/CLLCT/002 Detail C.</p> <p>Drainage: No works required.</p> <p>Signage: No works required.</p>

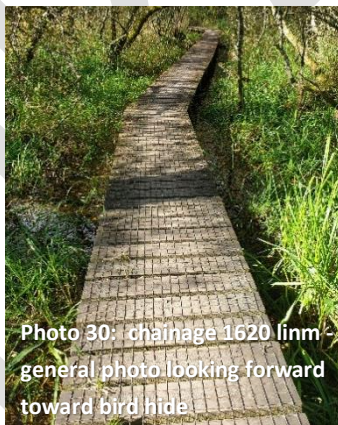
<p>Photo 30: chainage 1620 linm - general photo looking forward toward bird hide</p></div> <p>General photo of main route taken looking forward and showing mesh covered (from chainage 1620 linm) timber boardwalk. Surface height above water level was generally measured at 400mm at time of survey and reduces to 250mm near end of boardwalk at chainage 1682 linm.</p>					
Chainage (linm)	Slope Dir	Grad. (%/deg)	Width (m)	Current Path Condition		Description of Proposed Path Works

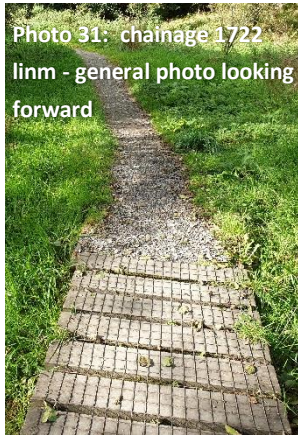
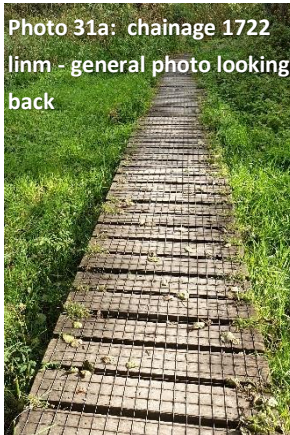
</div> <div>General photo showing end of boardwalk looking forward (Photo 31) and looking back (Photo 31a). Timber boardwalk transitions to compacted aggregate path at chainage 1724 linm.</div>	<div>Vegetation Management: Clear any overhanging vegetation, along length of route, to a height of not less than 3.5m from finished path surface (preferred height 3.7m) and any smaller encroaching vegetation not less than 1m from path edges and to a height of 50mm, unless otherwise noted within this technical assessment. All woody vegetation to be cut into manageable lengths and distributed across site within agreed locations.</div> <div>Barriers/Other features: No works required.</div> <div>Path construction and surfacing: Option 1: Carefully scrape back all encroaching verge vegetation to expose full width of previously installed path (estimated to be a minimum of 1.5m) and upgrade surface to Drawing CL/UPU/CLLCT/001. Construct path levels to max 1:40 camber throughout to allow any surface water run-off to be discharged off the path and into verge area on either side. All verge scrape arisings to be utilised to reform path verges, ensuring finished verge levels remain below path surface levels to allow surface water run-off. Option 1a: Construct additional side link path to provide users with a more gradient friendly alternative. Alternative route extends to approx. 40linm and passes under mature beech trees to right of existing path, as viewed looking forward, before reconnecting with existing path at top of slope. Option 2: Assumes no upgrade works, as detailed within Option 1. Maintain usable path surface width by regularly cutting back verge vegetation to a width of 1m on either side. Consideration to be given to undertaking a phased programme of maintenance works aimed at carefully scraping back existing verge to expose original path width. Alternative is to apply appropriate herbicide to encroaching ground vegetation and to a width not exceeding original path base width (requires PA1/PA6a certification). Occasional compaction of surface.</div> <div>Drainage: No works required.</div> <div>Signage: No works required.</div>

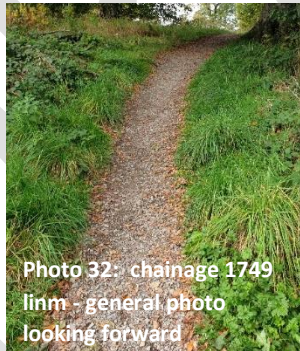
</div> <div>Route ramps steeply upward by large Beech tree to right. Gradient measured at 12%/7deg. Surface remains as compacted aggregate and to a width of approx. 0.6m. Possible link to right of path would allow creation of a reduced gradient ramp for less able users. Top of ramp at chainage 1770 linm.</div>					
Chainage (linm)	Slope Dir	Grad. (%/deg)	Width (m)	Current Path Condition	Description of Proposed Path Works

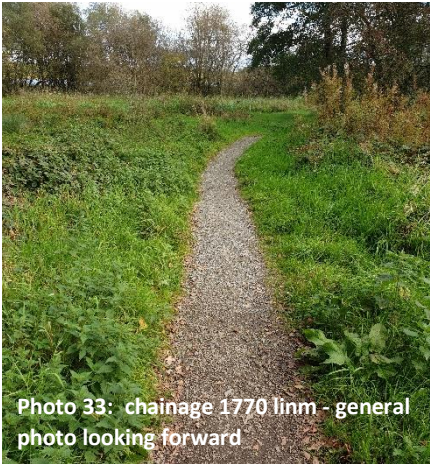
<p>Photo 33: chainage 1770 linm - general photo looking forward</p> <p>Route continues from top of ramp, at chainage 1770 linm, to end of path section at chainage 1804 linm. Path surface continues as compacted aggregate to a width of approx. 0.6m.</p>		<p>Vegetation Management: Clear any overhanging vegetation, along length of route, to a height of not less than 3.5m from finished path surface (preferred height 3.7m) and any smaller encroaching vegetation not less than 1m from finished boardwalk/path edges and to a height of 50mm, unless otherwise noted within this technical assessment. All woody vegetation to be cut into manageable lengths and distributed across site within agreed locations.</p> <p>Barriers/Other features: No works required.</p> <p>Path construction and surfacing: Option 1: Carefully scrape back all encroaching verge vegetation to expose full width of previously installed path (estimated to be a minimum of 1.5m) and upgrade surface to Drawing CL/UPU/CLLCT/001. Construct path levels to max 1:40 camber throughout to allow any surface water run-off to be discharged off the path and into verge area on either side. All verge scrape arisings to be utilised to reform path verges, ensuring finished verge levels remain below path surface levels to allow surface water run-off.</p> <p>Option 2: Assumes no upgrade works, as detailed within Option 1. Maintain usable path surface width by regularly cutting back verge vegetation to a width of 1m on either side. Consideration to be given to undertaking a phased programme of maintenance works aimed at carefully scraping back existing verge to expose original path width. Alternative is to apply appropriate herbicide to encroaching ground vegetation and to a width not exceeding original path base width (requires PA1/PA6a certification). Occasional compaction of surface.</p> <p>Drainage: No works required.</p> <p>Signage: No works required.</p>

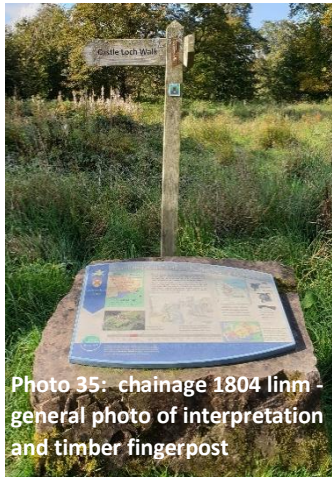
<p>Photo 35: chainage 1804 linm - general photo of interpretation and timber fingerpost</p>

<p>Photo 35a: chainage 1804 linm general photo of interpretation and timber fingerpost</p> <p>General photos showing interpretation panel and timber fingerpost by Lochmaben Castle carparking area.</p>	Vegetation Management: Clear any overhanging vegetation, along length of route, to a height of not less than 3.5m from track surface (preferred height 3.7m). All woody vegetation to be cut into manageable lengths and distributed within site within agreed locations.						
1804 - 1907	↔	/	2.4	<p>Route proceeds along Lochmaben Castle access track and is composed of heavily compacted aggregate. Track measured at approx. 2.4m width at chainage 1827 linm.</p>					Barriers/Other features: No works required.

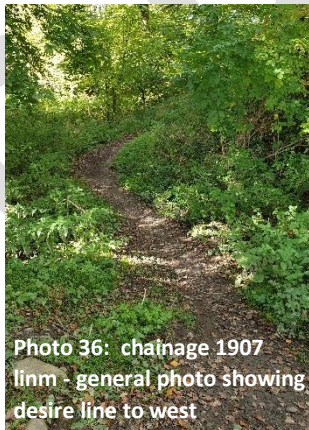
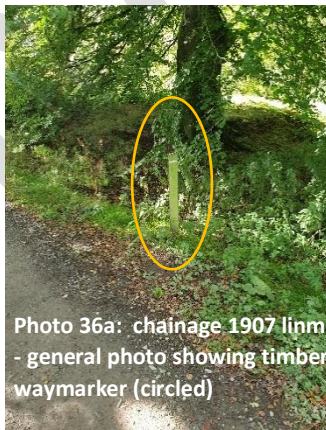
<p>Photo 36: chainage 1907 linm - general photo showing desire line to west</p>

<p>Photo 36a: chainage 1907 linm - general photo showing timber waymarker (circled)</p> <p>General photos showing well used desire line to right (west). Some evidence that this route has been surfaced in the path with areas of exposed aggregate to start. Route not included within this survey.</p>	Path construction and surfacing: No works required.					Drainage: No works required.	
					Signage: Incorporate sign condition inspection and clearance of ground vegetation around post base into annual maintenance schedule. Incorporate interpretation sign cleaning into annual maintenance schedule.						
Chainage (linm)	Slope Dir	Grad. (%/deg)	Width (m)	Current Path Condition			Description of Proposed Path Works

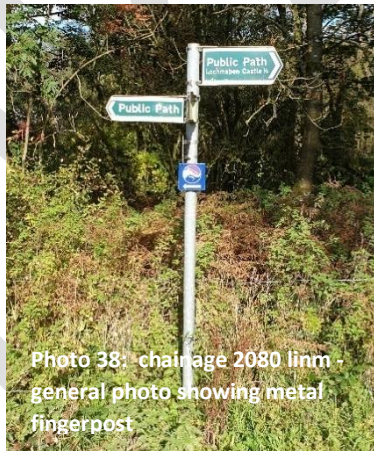
</div> <p>Photo 38: chainage 2080 linm - general photo showing metal fingerpost</p> <p>General photo showing metal fingerpost to right of route and opposite farm access road to south. Post showing age but is in an acceptable condition.</p>					
2020 - 2176									
Chainage (linm)	Slope Dir	Grad. (%/deg)	Width (m)	Current Path Condition			Description of Proposed Path Works

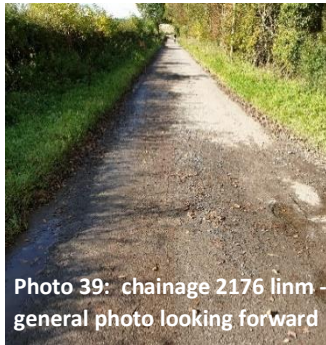
</div> <p>General photo looking forward and showing farm access road/track. Surface transitions from compacted aggregate to bound bitmac at this point.</p>			<p>Vegetation Management: Clear any overhanging vegetation, along length of route, to a height of not less than 3.5m from track surface (preferred height 3.7m). All woody vegetation to be cut into manageable lengths and distributed within site within agreed locations.</p> <p>Barriers/Other features: Consideration to be given to removing existing gate. Option to leave frame in place to allow possible future reinstatement, if desired.</p> <p>Path construction and surfacing: No works required.</p> <p>Drainage: No works required.</p> <p>Signage: Incorporate sign condition inspection and clearance of ground vegetation around post base into annual maintenance schedule.</p>

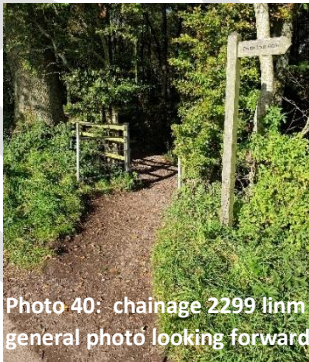
</div> <p>General photo looking north at point route departs from farm access road and heads into woodland area via gentle downhill ramp before levelling out past gate. 1-way steel self-closing access gate installed at entrance to wood (chainage 2305) and was propped open at time of survey. Route surface returns to compacted Type 1 aggregate, with some loose surface stones, at approx. 1.0m in width.</p>					
2299 - 2305	↔	/	1.0	Route surface continues through woodland. Path surface continues as compacted aggregate at approx. 1.0m width.					
Chainage (linm)	Slope Dir	Grad. (%/deg)	Width (m)	Current Path Condition			Description of Proposed Path Works

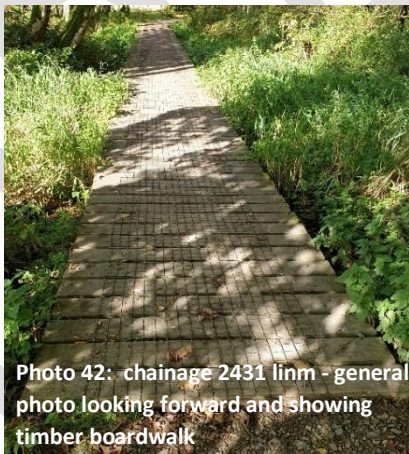
<p>Photo 42: chainage 2431 linm - general photo looking forward and showing timber boardwalk</p></div> <p>General photo looking forward and showing transition from compacted aggregate path to timber boardwalk with steel mesh anti-slip measures applied. Transition between path and boardwalk has 10-20mm step. Boardwalk measured at 1400mm wide with gaps between decking boards of 30mm. Measured height above ground was 250-300mm.</p>					
Chainage (linm)	Slope Dir	Grad. (%/deg)	Width (m)	Current Path Condition		Description of Proposed Path Works

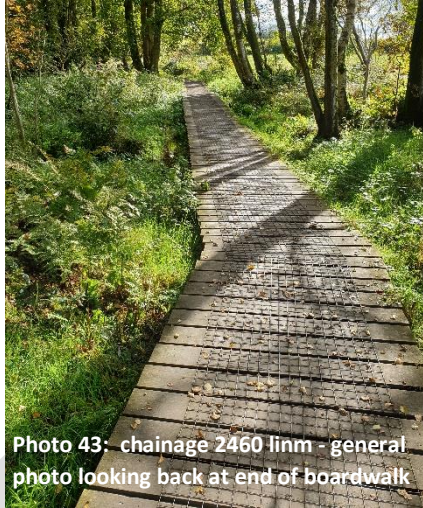
<p>Photo 43: chainage 2460 linm - general photo looking back at end of boardwalk</p></div> <p>General photo taken at end of boardwalk section looking back. Route transitions back to compacted granular aggregate.</p>					
2460	/	/	/						
						<p>Vegetation Management: Clear any overhanging vegetation, along length of route, to a height of not less than 3.5m from finished deck surface (preferred height 3.7m) and any smaller encroaching vegetation not less than 1m from boardwalk edges, unless otherwise noted within this technical assessment. All woody vegetation to be cut into manageable lengths and distributed across site within agreed locations.</p> <p>Barriers/Other features: Structure and ongoing maintenance of bird hide not included within the scope of this study.</p> <p>Path construction and surfacing: Boardwalk: Retain existing boardwalk structure. Remove existing steel mesh and replace with new GRP anti-slip strips (50mm wide x 1200mm long). Option A: install toe boards to either edge of existing structure and as detailed within Drawing No. CL/LLW/CLLCT/002. Option B: Install a single passing place to general detail shown within Drawing No. CL/LLW/CLLCT/002 Detail C. Option C: Remove existing raised walkway and replace with new; to a width not less than 1600mm and to Drawing No. CL/LLW/CLLCT/002.</p> <p>Drainage: No works required.</p> <p>Signage: No works required.</p>

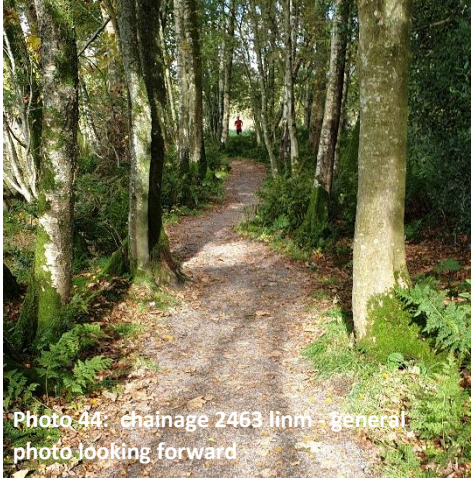
<p>Photo 44: chainage 2463 linm - general photo looking forward</p> <p>Route continues north through deciduous woodland. Path surface composed of compacted aggregate (smaller stone size than previous sections) to a measured width of 1.2m. General photo taken at chainage 2463 linm looking forward.</p>					<p>Vegetation Management: Clear any overhanging vegetation, along length of route, to a height of not less than 3.5m from finished path surface (preferred height 3.7m) and any smaller encroaching vegetation not less than 1m from path edges and to a height of 50mm, unless otherwise noted within this technical assessment. All woody vegetation to be cut into manageable lengths and distributed across site within agreed locations.</p> <p>Barriers/Other features: No works required.</p> <p>Path construction and surfacing: Option 1: Carefully scrape back all encroaching verge vegetation to expose full width of previously installed path (estimated to be a minimum of 1.5m) and upgrade surface to Drawing CL/UPU/CLLCT/001. Construct path levels to max 1:40 camber throughout to allow any surface water run-off to be discharged off the path and into verge area on either side. All verge scrape arisings to be utilised to reform path verges, ensuring finished verge levels remain below path surface levels to allow surface water run-off.</p> <p>Option 2: Assumes no upgrade works, as detailed within Option 1. Maintain usable path surface width by regularly cutting back verge vegetation to a width of 1m on either side. Consideration to be given to undertaking a phased programme of maintenance works aimed at carefully scraping back existing verge to expose original path width. Alternative is to apply appropriate herbicide to encroaching ground vegetation and to a width not exceeding original path base width (requires PA1/PA6a certification). Occasional compaction of surface.</p> <p>Drainage: For path construction options 1 and 2: Install drainage letts along the verge to better enable surface water run-off and to alleviate any possible ponding along the edges of the path surface. Locate as required and to a min width of 200mm.</p> <p>Signage: No works required.</p>

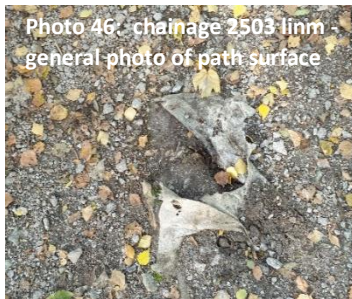
Photo 46: chainage 2503 linm - general photo of path surface General photo showing exposed Terram geotextile in centre of path surface.					
2511 - 2530	↔	/	1.2	Route continues north through woodland and meanders gently through wooded area. Surface remains as compacted aggregate to a width of 1.2m					
2530	/	/	/

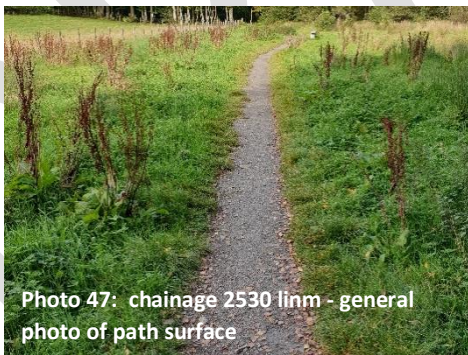
Photo 47: chainage 2530 linm - general photo of path surface General photo looking forward at point route exists woodland into open ground.					
2530 - 2560	↔	/	0.6	Route exists into open grassland area and narrows to 0.6mm in width. Surface remains as compacted aggregate throughout. Verges have built up above surface level of path.					
Chainage (linm)	Slope Dir	Grad. (%/deg)	Width (m)	Current Path Condition		Description of Proposed Path Works

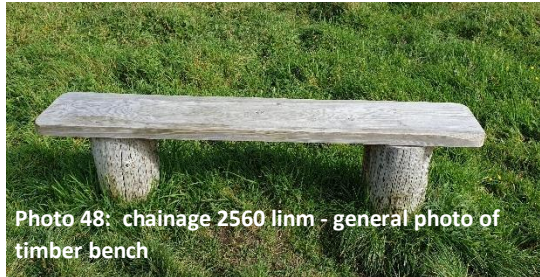
<p>Photo 48: chainage 2560 linm - general photo of timber bench</p> <p>General photo showing simple timber bench to right of route.</p>						<p>Vegetation Management:</p> <p>Clear any overhanging vegetation, along length of route, to a height of not less than 3.5m from finished path surface (preferred height 3.7m) and any smaller encroaching vegetation not less than 1m from path edges and to a height of 50mm, unless otherwise noted within this technical assessment.</p> <p>All woody vegetation to be cut into manageable lengths and distributed across site within agreed locations.</p> <p>Barriers/Other features:</p> <p>Regularly remove all vegetation growing around and under bench seat.</p> <p>Path construction and surfacing:</p> <p>Option 1: Carefully scrape back all encroaching verge vegetation to expose full width of previously installed path (estimated to be a minimum of 1.5m) and upgrade surface to Drawing CL/UPU/CLLCT/001. Construct path levels to max 1:40 camber throughout to allow any surface water run-off to be discharged off the path and into verge area on either side. All verge scrape arisings to be utilised to reform path verges, ensuring finished verge levels remain below path surface levels to allow surface water run-off.</p> <p>Option 2: Assumes no upgrade works, as detailed within Option 1. Maintain usable path surface width by regularly cutting back verge vegetation to a width of 1m on either side. Consideration to be given to undertaking a phased programme of maintenance works aimed at carefully scraping back existing verge to expose original path width. Alternative is to apply appropriate herbicide to encroaching ground vegetation and to a width not exceeding original path base width (requires PA1/PA6a certification). Occasional compaction of surface.</p> <p>Drainage:</p> <p>For path construction options 1 and 2: Install drainage letts along the verge to better enable surface water run-off and to alleviate any possible ponding along the edges of the path surface. Locate as required and to a min width of 200mm.</p> <p>Signage:</p> <p>No works required.</p>

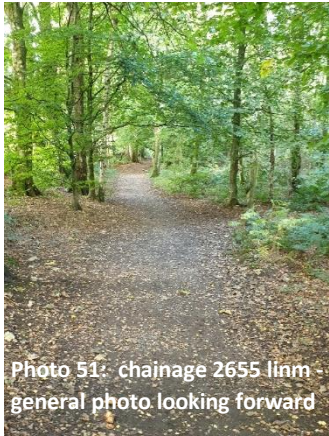
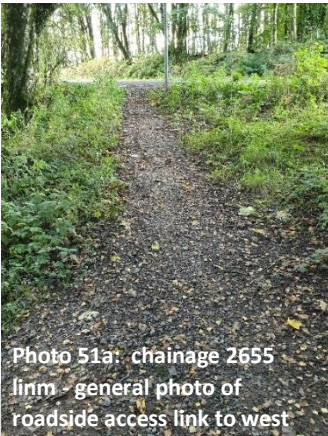
<p>Photo 51: chainage 2655 linm - general photo looking forward</p> <p>Photo 51a: chainage 2655 linm - general photo of roadside access link to west</p> <p>General photo showing route looking forward (photo 51) and side link to left which connects path to roadside lay-by (51a).</p>		<p>Vegetation Management: Clear any overhanging vegetation, along length of route, to a height of not less than 3.5m from finished path surface (preferred height 3.7m) and any smaller encroaching vegetation not less than 1m from path edges and to a height of 50mm, unless otherwise noted within this technical assessment. All woody vegetation to be cut into manageable lengths and distributed across site within agreed locations.</p> <p>Barriers/Other features: Regularly remove all vegetation growing around and under bench seat.</p> <p>Path construction and surfacing: Option 1: Carefully scrape back all encroaching verge vegetation to expose full width of previously installed path (estimated to be a minimum of 1.5m) and upgrade surface to Drawing CL/UPU/CLLCT/001. Construct path levels to max 1:40 camber throughout to allow any surface water run-off to be discharged off the path and into verge area on either side. All verge scrape arisings to be utilised to reform path verges, ensuring finished verge levels remain below path surface levels to allow surface water run-off.</p> <p>Option 2: Assumes no upgrade works, as detailed within Option 1. Maintain usable path surface width by regularly cutting back verge vegetation to a width of 1m on either side. Consideration to be given to undertaking a phased programme of maintenance works aimed at carefully scraping back existing verge to expose original path width. Alternative is to apply appropriate herbicide to encroaching ground vegetation and to a width not exceeding original path base width (requires PA1/PA6a certification). Occasional compaction of surface.</p> <p>Drainage: For path construction options 1 and 2: Install drainage letts along the verge to better enable surface water run-off and to alleviate any possible ponding along the edges of the path surface. Locate as required and to a min width of 200mm. Clear inlet and outlet channels to piped culvert and rod out accumulated material within pipe to re-establish full functionality. Incorporate culvert and associated ditch condition inspection and clearance into annual maintenance schedule.</p> <p>Signage: No works required.</p>

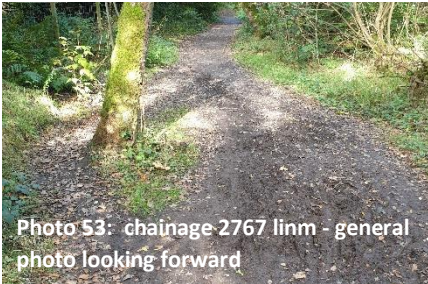
<p>Photo 53: chainage 2767 linm - general photo looking forward</p></div> <p>General photo looking forward and showing widened muddy section on path with by-pass route to left, around tree. General wear on by-pass suggests that this is a longer-term issue.</p> <p>Route continues north through shaded woodland edge. Path surface composed of compacted aggregate. Accumulated leaf litter and silt has allowed mud to form over surface.</p> <p>Muddy section ends at chainage 2776 linm and path surface returns to exposed compacted aggregate. Path runs close to boundary post and wire fence to left.</p> <div>

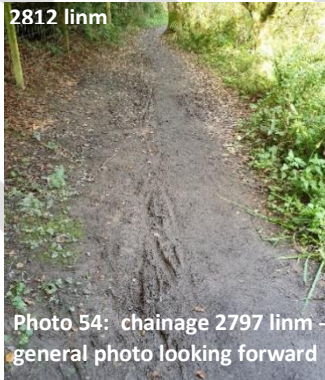
<p>Photo 54: chainage 2797 linm - general photo looking forward</p></div> <p>General photo looking forward and showing muddy section from chainages 2792 - 2810 linm.</p>

2767	/	/	/						
2767 - 2776	↔	/	/						
2776 - 2797	↔	/	1.2						
2792 - 2810	↔	/	1.2						
Vegetation Management: Clear any overhanging vegetation, along length of route, to a height of not less than 3.5m from finished path surface (preferred height 3.7m) and any smaller encroaching vegetation not less than 1m from path edges and to a height of 50mm, unless otherwise noted within this technical assessment. All woody vegetation to be cut into manageable lengths and distributed across site within agreed locations.						Barriers/Other features: Regularly remove all vegetation growing around and under bench seat.			
Path construction and surfacing: Option 1: Carefully scrape back all encroaching verge vegetation to expose full width of previously installed path (estimated to be a minimum of 1.5m) and upgrade surface to Drawing CL/UPU/CLLCT/001. Construct path levels to max 1:40 camber throughout to allow any surface water run-off to be discharged off the path and into verge area on either side. All verge scrape arisings to be utilised to reform path verges, ensuring finished verge levels remain below path surface levels to allow surface water run-off.						Option 2: Assumes no upgrade works, as detailed within Option 1. Generally scrape accumulated mud from the path surface and dispose of arisings well away from path edges. Maintain usable path surface width by regularly cutting back verge vegetation to a width of 1m on either side. Consideration to be given to undertaking a phased programme of maintenance works aimed at carefully scraping back existing verge to expose original path width. Alternative is to apply appropriate herbicide to encroaching ground vegetation and to a width not exceeding original path base width (requires PA1/PA6a certification). Occasional compaction of surface.

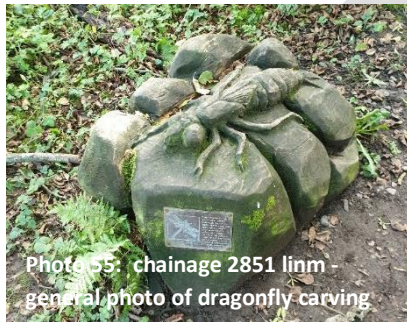
Photo 55: chainage 2851 linm - general photo of dragonfly carving General photo showing dragonfly carving to right of path.					
2851 - 2908	↔	/	1.2	Route continues alongside boundary fence and parallel with B7020 to west. Surface compose of compacted aggregate with surface layer of compacted leaf litter, and silt/soil migration from embankment to left, creating a slightly muddy walking surface.					
2908	/	/	/

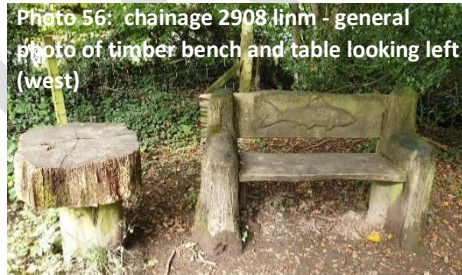
Photo 56: chainage 2908 linm - general photo of timber bench and table looking left (west) General photo of rustic timber bench and side table at chainage 2908 linm. Furniture located in heavy shade with no outlook/view to east.					
Chainage (linm)	Slope Dir	Grad. (%/deg)	Width (m)	Current Path Condition		Description of Proposed Path Works

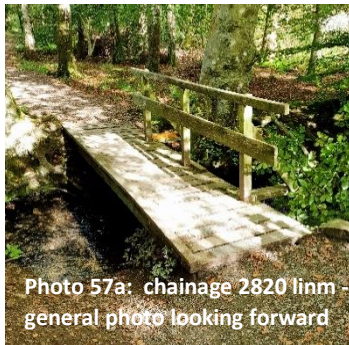
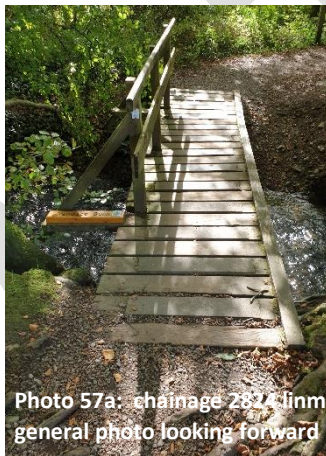
</div></div></div> <p>General photos showing simple, 4m span timber bridge with partial single handrail over Vendace Burn. Decking has aftermarket anti-slip strips applied.</p>						
2920 - 2924	↔	/
