Technical Assessment

Path Maintenance and Improvement Works to Castle Loch Walk, Lochmaben

Paths for All Partnership
Kintail House,
Forthside Way,
Stirling, FK8 1QZ

Produced on: January 2020

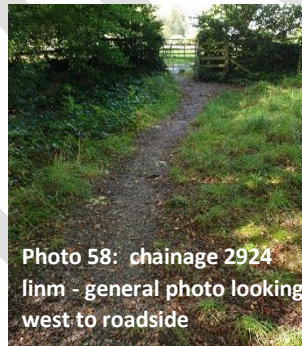
</div></div></div> <p>General photo showing 14 linm link path to roadside lay-by on B7020. Steel 1-way self-closing gate installed at lay-by. Gradient not measured at time of survey.</p>	<div><div><div>Vegetation Management:</div><div>Clear any overhanging vegetation, along length of route, to a height of not less than 3.5m from finished path surface (preferred height 3.7m) and any smaller encroaching vegetation not less than 1m from path edges and to a height of 50mm, unless otherwise noted within this technical assessment.</div><div>All woody vegetation to be cut into manageable lengths and distributed across site within agreed locations.</div></div><div><div>Barriers/Other features:</div><div>Bridge: Incorporate bridge condition inspection into annual maintenance schedule. Remove all vegetation adjacent or overhanging bridge structure. Uphill path surface approaches to bridge to remove any stepped level variances. Option: extend handrail to at least the full length of the bridge or replace full structure.</div><div>Gate: Consideration to be given to removing existing gate a roadside lay-by. Option to leave frame in place to allow possible future reinstatement, if desired.</div></div><div><div>Path construction and surfacing:</div><div>Option 1: Carefully scrape back all encroaching verge vegetation to expose full width of previously installed path (estimated to be a minimum of 1.5m) and upgrade surface to Drawing CL/UPU/CLLCT/001. Construct path levels to max 1:40 camber throughout to allow any surface water run-off to be discharged off the path and into verge area on either side. All verge scrape arisings to be utilised to reform path verges, ensuring finished verge levels remain below path surface levels to allow surface water run-off.</div><div>Option 2: Assumes no upgrade works, as detailed within Option 1. Generally scrape accumulated mud from the path surface and dispose of arisings well away from path edges. Maintain usable path surface width by regularly cutting back verge vegetation to a width of 1m on either side. Consideration to be given to undertaking a phased programme of maintenance works aimed at carefully scraping back existing verge to expose original path width. Alternative is to apply appropriate herbicide to encroaching ground vegetation and to a width not exceeding original path base width (requires PA1/PA6a certification). Occasional compaction of surface.</div></div><div><div>Drainage:</div><div>No works required.</div></div><div><div>Signage:</div><div>No works required.</div></div></div>

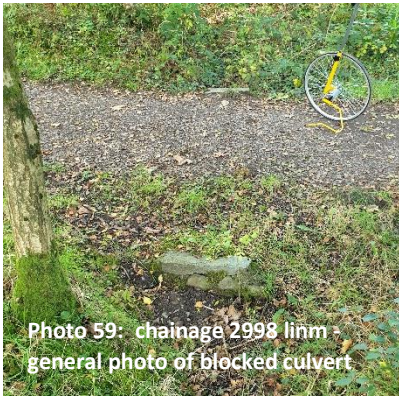
<p>Photo 59: chainage 2998 linm - general photo of blocked culvert</p></div> <p>General photo showing twinwall piped culvert, with simple mortared stone headwalls, taking water under path from left to right. Pipe inlet completely blocked with soil.</p>					
2998 - 3008		↔	/	1.7	Route continues north through woodland and remains parallel to the B7020 carriageway. Surface remains as compacted Type 1 aggregate.					
3008		/	/	/	<div>

Path Survey and Specification Sheet								Sheet No.	33	
Location:		Castle Loch, Lochmaben, Dumfries and Galloway				Weather:	Dry, sunny intervals	Surveyor:	G Anderson	
Path:		Castle Loch Circular Route				Date:	05.10.20	Section:	Chainage (2924 – 3008 linm)	
2924 - 2998		↔	/	1.7	Route continues north through woodland and remains parallel to the B7020 carriageway. Surface remains as compacted Type 1 aggregate. Path slightly wider along this section at 1.7m.	<div>Vegetation Management:</div> <p>Clear any overhanging vegetation, along length of route, to a height of not less than 3.5m from finished path surface (preferred height 3.7m) and any smaller encroaching vegetation not less than 1m from path edges and to a height of 50mm, unless otherwise noted within this technical assessment. All woody vegetation to be cut into manageable lengths and distributed across site within agreed locations.</p> <div>Barriers/Other features:</div> <p>Incorporate general inspection and seat cleaning into annual maintenance schedule Regularly remove all vegetation growing around and under bench seat.</p> <div>Path construction and surfacing:</div> <p>Option 1: Carefully scrape back all encroaching verge vegetation to expose full width of previously installed path (estimated to be a minimum of 1.5m) and upgrade surface to Drawing CL/UPU/CLLCT/001. Construct path levels to max 1:40 camber throughout to allow any surface water run-off to be discharged off the path and into verge area on either side. All verge scrape arisings to be utilised to reform path verges, ensuring finished verge levels remain below path surface levels to allow surface water run-off.</p> <p>Option 2: Assumes no upgrade works, as detailed within Option 1. Maintain usable path surface width by regularly cutting back verge vegetation to a width of 1m on either side. Consideration to be given to undertaking a phased programme of maintenance works aimed at carefully scraping back existing verge to expose original path width. Alternative is to apply appropriate herbicide to encroaching ground vegetation and to a width not exceeding original path base width (requires PA1/PA6a certification). Occasional compaction of surface.</p> <div>Drainage:</div> <p>For path construction options 1 and 2: Install drainage letts along the verge to better enable surface water run-off and to alleviate any possible ponding along the edges of the path surface. Locate as required and to a min width of 200mm. Clear inlet and outlet channels to piped culvert and rod out accumulated material within pipe to re-establish full functionality. Incorporate culvert and associated ditch condition inspection and clearance into annual maintenance schedule.</p> <div>Signage:</div> <p>No works required.</p>

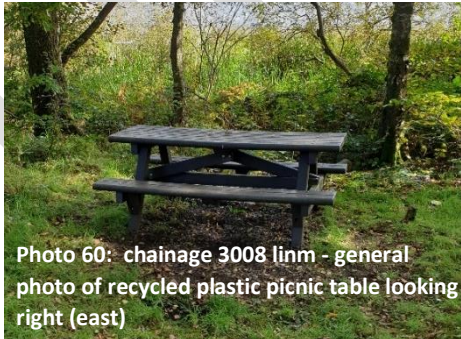
<p>Photo 60: chainage 3008 linm - general photo of recycled plastic picnic table looking right (east)</p></div> <p>General photo showing recycled plastic picnic table to right of path. Bench located on open ground with no formal/hard base.</p>					
Chainage (linm)	Slope Dir	Grad. (%/deg)	Width (m)	Current Path Condition

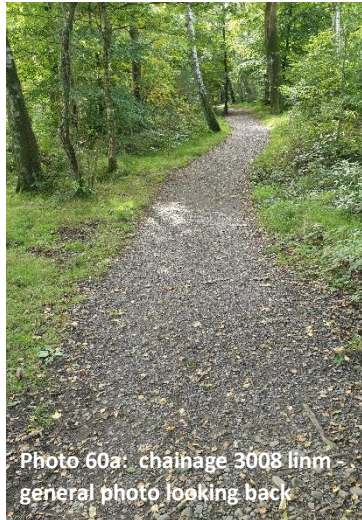
General photo looking back at chainage 3008 linm.	<p>Vegetation Management: Clear any overhanging vegetation, along length of route, to a height of not less than 3.5m from finished path surface (preferred height 3.7m) and any smaller encroaching vegetation not less than 1m from path edges and to a height of 50mm, unless otherwise noted within this technical assessment. All woody vegetation to be cut into manageable lengths and distributed across site within agreed locations.</p> <p>Barriers/Other features: Regularly remove all vegetation growing around and under bench seat.</p> <p>Path construction and surfacing: Option 1: Carefully scrape back all encroaching verge vegetation to expose full width of previously installed path (estimated to be a minimum of 1.5m) and upgrade surface to Drawing No. CL/UPU/CLLCT/001. Construct path levels to max 1:40 camber throughout to allow any surface water run-off to be discharged off the path and into verge area on either side. All verge scrape arisings to be utilised to reform path verges, ensuring finished verge levels remain below path surface levels to allow surface water run-off.</p> <p>Option 2: Assumes no upgrade works, as detailed within Option 1. Maintain usable path surface width by regularly cutting back verge vegetation to a width of 1m on either side. Consideration to be given to undertaking a phased programme of maintenance works aimed at carefully scraping back existing verge to expose original path width. Alternative is to apply appropriate herbicide to encroaching ground vegetation and to a width not exceeding original path base width (requires PA1/PA6a certification). Occasional compaction of surface.</p> <p>Link Path: Install new path to general detail contained within Drawing No. CL/UPU/CLLCT/001 but ensuring min 100mm depth of base material.</p> <p>Drainage: For path construction options 1 and 2: Install drainage letts along the verge to better enable surface water run-off and to alleviate any possible ponding along the edges of the path surface. Locate as required and to a min width of 200mm.</p> <p>Signage: No works required.</p>

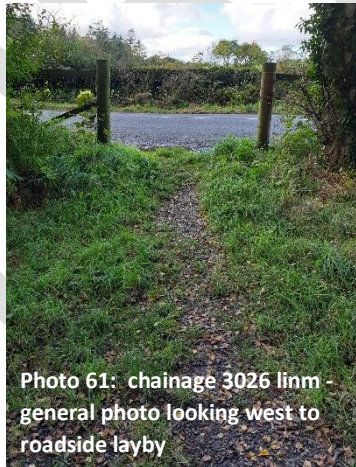
General photo showing 5m long link path to roadside lay-by on B7020. Gap in fence has no access barrier.					
Chainage (linm)	Slope Dir	Grad. (%/deg)	Width (m)	Current Path Condition		Description of Proposed Path Works

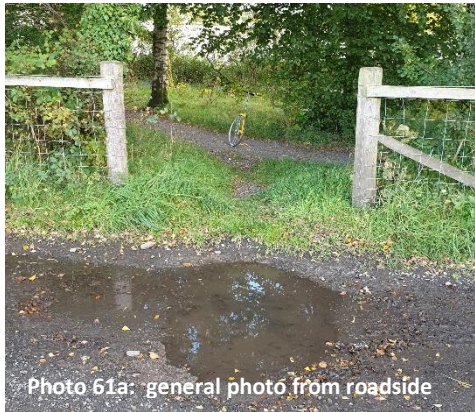
General photo from lay-by toward route path (west) and showing no barrier present.	<p>Vegetation Management: Clear any overhanging vegetation, along length of route, to a height of not less than 3.5m from finished path surface (preferred height 3.7m) and any smaller encroaching vegetation not less than 1m from path edges and to a height of 50mm, unless otherwise noted within this technical assessment. All woody vegetation to be cut into manageable lengths and distributed across site within agreed locations.</p> <p>Barriers/Other features: Bridge: Incorporate bridge condition inspection into annual maintenance schedule. Remove all vegetation adjacent or overhanging bridge structure. Uphill path surface approaches to bridge to remove any stepped level variances. Option: replace full structure ensuring minimum clear width of 1.5m.</p> <p>Path construction and surfacing: Option 1: Carefully scrape back all encroaching verge vegetation to expose full width of previously installed path (estimated to be a minimum of 1.5m) and upgrade surface to Drawing CL/UPU/CLLCT/001. Construct path levels to max 1:40 camber throughout to allow any surface water run-off to be discharged off the path and into verge area on either side. All verge scrape arisings to be utilised to reform path verges, ensuring finished verge levels remain below path surface levels to allow surface water run-off.</p> <p>Link Path: Install new path to general detail contained within Drawing No. CL/UPU/CLLCT/001 but ensuring min 100mm depth of base material.</p> <p>Option 2: Assumes no upgrade works, as detailed within Option 1. Maintain usable path surface width by regularly cutting back verge vegetation to a width of 1m on either side. Consideration to be given to undertaking a phased programme of maintenance works aimed at carefully scraping back existing verge to expose original path width. Alternative is to apply appropriate herbicide to encroaching ground vegetation and to a width not exceeding original path base width (requires PA1/PA6a certification). Occasional compaction of surface.</p> <p>Signage: Option: Install fingerpost signage indicating access to circular route and picnic/recreation area</p>

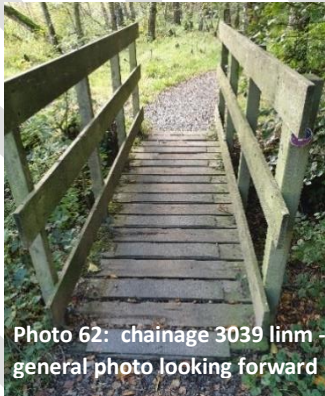
General photo showing 3.2m span timber bridge with double handrail and anti-slip aftermarket strips to alternate decking boards. Bridge 900mm wide with 1170mm high parapets. Limited stepped transition between aggregate path and decking boards where path surface is lower than bridge deck.					
Chainage (linm)	Slope Dir	Grad. (%/deg)	Width (m)	Current Path Condition		Description of Proposed Path Works

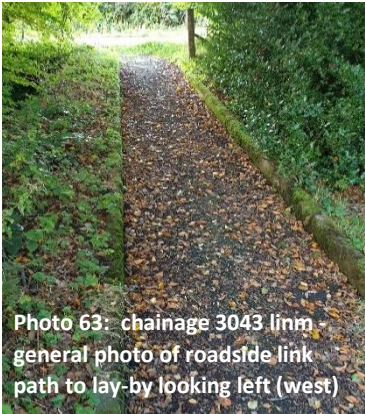
<p>Photo 63: chainage 3043 linm - general photo of roadside link path to lay-by looking left (west)</p></div> <p>General photo showing formalised link path (15m in length) to roadside lay-by off B7020. No access barrier installed at lay-by. Link path has raised concrete kerbing and worn bound bitmac surface. Width approx 1.2m.</p>					
3043	↑	/	1.2						
3043	↓	/	/						
				<div><div>

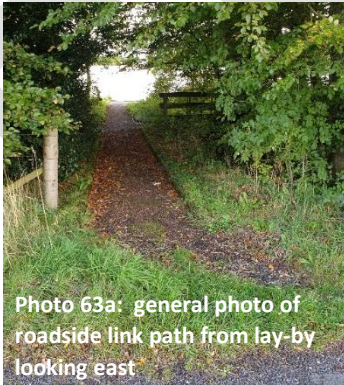
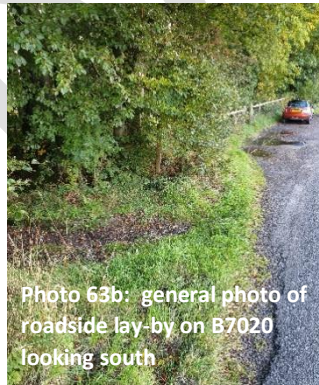
<p>Photo 63a: general photo of roadside link path from lay-by looking east</p></div><div>

<p>Photo 63b: general photo of roadside lay-by on B7020 looking south</p></div></div> <p>General photos of link path (photo 63a) and roadside lay-by (photo 63b).</p>

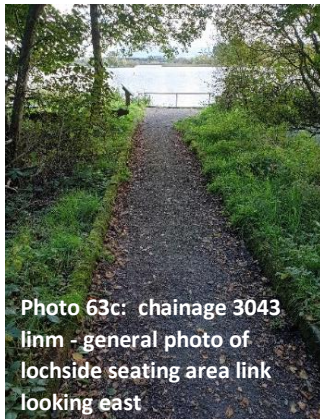
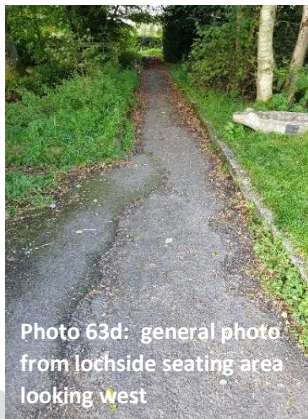
<p>Photo 63c: chainage 3043 linm - general photo of lochside seating area link looking east</p></div> <div>

<p>Photo 63d: general photo from lochside seating area looking west</p></div> <p>General photo showing continuation of formalised link path leading to lochside seating/viewing area. Photos are looking east from surveyed lochside route to seating area (photo 63c) and from seating area to surveyed route (63d).</p>		<p>Vegetation Management: Clear any overhanging vegetation, along length of route, to a height of not less than 3.5m from finished path surface (preferred height 3.7m) and any smaller encroaching vegetation not less than 1m from path edges and to a height of 50mm, unless otherwise noted within this technical assessment. All woody vegetation to be cut into manageable lengths and distributed across site within agreed locations.</p> <p>Barriers/Other features: Seating: Regularly maintain grassed seating area to ensure grass does not grow longer than 50mm. Consideration to be given to replace existing timber picnic bench with 2no. new (timber or recycled plastic).</p> <p>Path construction and surfacing: Generally maintain path surfaces through cleaning of any accumulated materials. Option to clear surface vegetation at lay-by to make the entrance more obvious and welcoming.</p> <p>Drainage: No works required.</p> <p>Signage: Incorporate interpretation sign cleaning into annual maintenance schedule.</p>

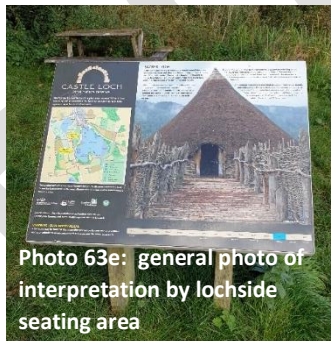
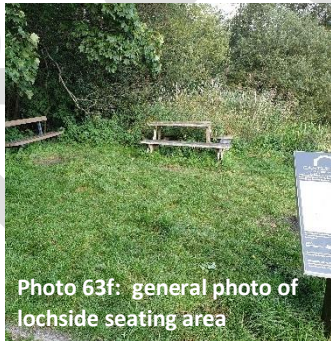
<p>Photo 63e: general photo of interpretation by lochside seating area</p></div> <div>

<p>Photo 63f: general photo of lochside seating area</p></div> <p>General photos taken at lochside seating/viewing area showing Crannog interpretation panel (photo 63e) and grassed seating/picnic area (photo 63f).</p>					
Chainage (linm)	Slope Dir	Grad. (%/deg)	Width (m)	Current Path Condition		Description of Proposed Path Works

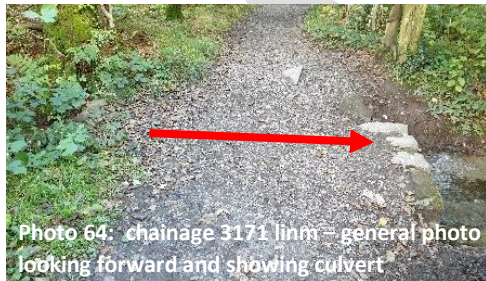
<p>Photo 64: chainage 3171 linm – general photo looking forward and showing culvert</p> <p>General photo showing 300mm dia. twinwall piped culvert with mortared stone headwalls. Water flowing freely from left to right (as shown).</p>					
3171		/	/	/

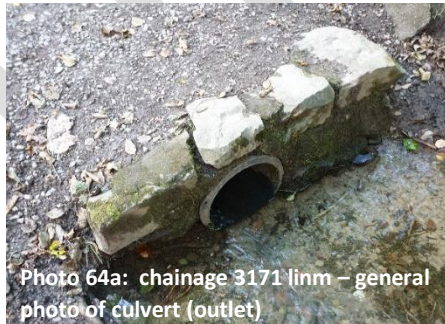
<p>Photo 64a: chainage 3171 linm – general photo of culvert (outlet)</p> <p>General photo of culver outlet.</p>					
Chainage (linm)		Slope Dir	Grad. (%/deg)	Width (m)	Current Path Condition	Description of Proposed Path Works

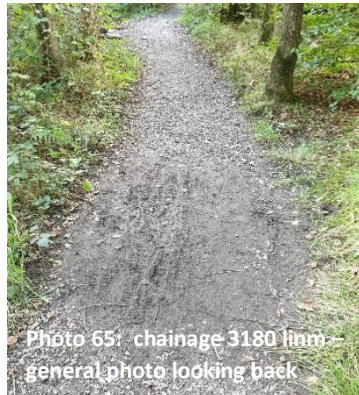
Photo 65: chainage 3180 linm - general photo looking back General photo taken looking back and showing dip in path level allowing water and mud to accumulate across width of surface.					
3180 - 3272	↔	/	<1.6	Route continues north through woodland and remains parallel to the B7020 carriageway. Surface composed of compacted Type 1 aggregate. Path width varies between 1.2 – 1.6m.					
3272	/	/	/

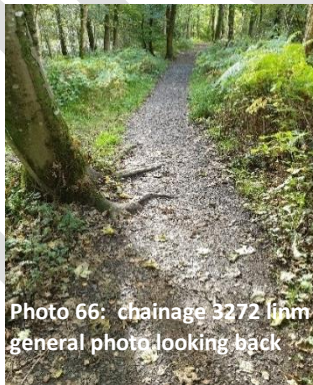
Photo 66: chainage 3272 linm - general photo looking back General photo looking back and showing tree roots encroaching into path surface.					
Chainage (linm)	Slope Dir	Grad. (%/deg)	Width (m)	Current Path Condition		Description of Proposed Path Works

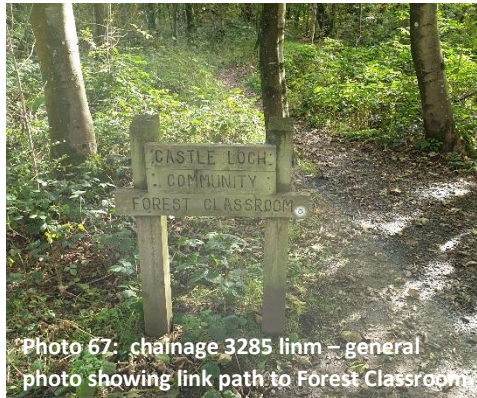
</div> <p>Photo 67: chainage 3285 linm – general photo showing link path to Forest Classroom</p> <p>General photo showing timber sign for ‘Forest Classroom’ to right of path.</p>							
3285	/	/	/	<div>

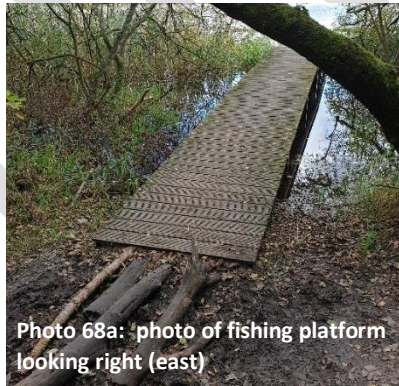
<p>Photo 68a: photo of fishing platform looking right (east)</p> <p>General photo showing timber platform into the Castle Loch and showing branches laid into mud for clearance.</p>

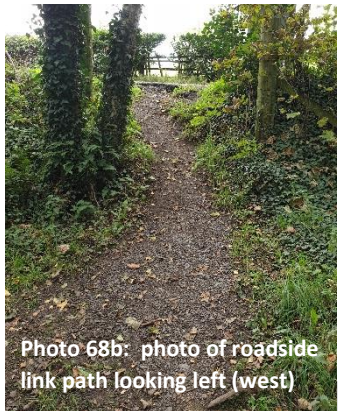
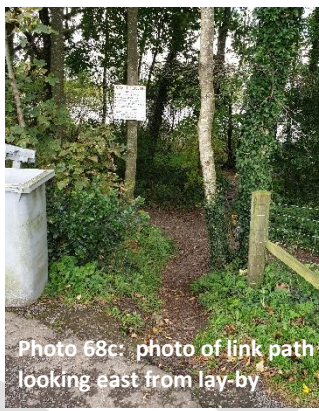
</div> <p>Photo 68b: photo of roadside link path looking left (west)</p> <p>Photo 68c: photo of link path looking east from lay-by</p> <p>General photos showing 17 linm link between surveyed route and B7020 (photo 68b) and from roadside lay-by looking down to surveyed route (photo 68c).</p>		<p>Vegetation Management:</p> <p>Clear any overhanging vegetation, along length of route, to a height of not less than 3.5m from finished path surface (preferred height 3.7m) and any smaller encroaching vegetation not less than 1m from path edges and to a height of 50mm, unless otherwise noted within this technical assessment.</p> <p>All woody vegetation to be cut into manageable lengths and distributed across site within agreed locations.</p> <p>Barriers/Other features:</p> <p>No works required.</p> <p>Path construction and surfacing:</p> <p>Option 1: Carefully scrape back all encroaching verge vegetation to expose full width of previously installed path (estimated to be a minimum of 1.5m) and upgrade surface to Drawing CL/UPU/CLLCT/001. Construct path levels to max 1:40 camber throughout to allow any surface water run-off to be discharged off the path and into verge area on either side. All verge scrape arisings to be utilised to reform path verges, ensuring finished verge levels remain below path surface levels to allow surface water run-off.</p> <p>Option 2: Assumes no upgrade works, as detailed within Option 1. Generally scrape accumulated mud from the path surface and dispose of arisings well away from path edges. Maintain usable path surface width by regularly cutting back verge vegetation to a width of 1m on either side. Consideration to be given to undertaking a phased programme of maintenance works aimed at carefully scraping back existing verge to expose original path width. Alternative is to apply appropriate herbicide to encroaching ground vegetation and to a width not exceeding original path base width (requires PA1/PA6a certification). Occasional compaction of surface.</p> <p>Link Path: Install new path from road to timber platform to general detail contained within Drawing No. CL/UPU/CLLCT/001 but ensuring min 100mm depth of base material.</p> <p>Drainage:</p> <p>For path construction options 1 and 2: Install drainage letts along the verge to better enable surface water run-off and to alleviate any possible ponding along the edges of the path surface. Locate as required and to a min width of 200mm.</p>

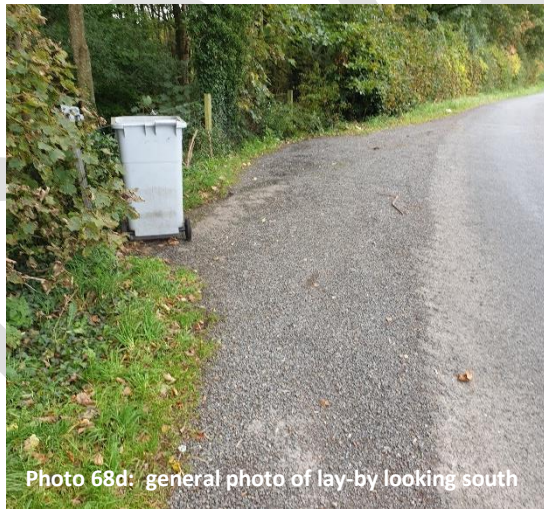
</div> <p>Photo 68d: general photo of lay-by looking south</p> <p>General photo of roadside lay-by off B7020 looking south.</p>		<p>Signage:</p> <p>Option: Install fingerpost signage indicating access to circular route and picnic/recreation area</p>					
3371 - 3387	↔	/	<1.6	Route continues north through woodland and remains parallel to the B7020 carriageway. Surface composed of compacted Type 1 aggregate.							
Chainage (linm)	Slope Dir	Grad. (%/deg)	Width (m)	Current Path Condition				Description of Proposed Path Works

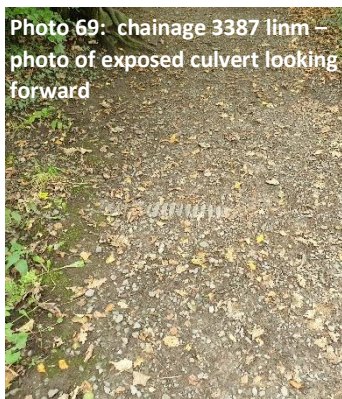
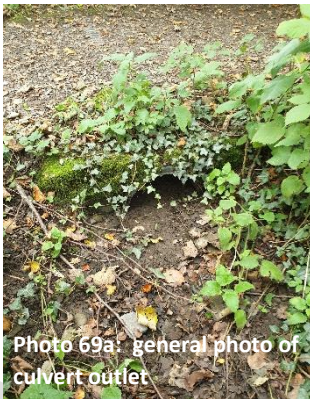
</div></div> <p>General photo showing twinwall piped culvert exposed through path surface (photo 69) and part blocked outlet to piped culvert (photo 69a). Water flow left to right under path.</p>	<p>Vegetation Management: Clear any overhanging vegetation, along length of route, to a height of not less than 3.5m from finished path surface (preferred height 3.7m) and any smaller encroaching vegetation not less than 1m from path edges and to a height of 50mm, unless otherwise noted within this technical assessment. All woody vegetation to be cut into manageable lengths and distributed across site within agreed locations.</p> <p>Barriers/Other features: No works required.</p> <p>Path construction and surfacing: Option 1: Carefully scrape back all encroaching verge vegetation to expose full width of previously installed path (estimated to be a minimum of 1.5m) and upgrade surface to Drawing CL/UPU/CLLCT/001. Construct path levels to max 1:40 camber throughout to allow any surface water run-off to be discharged off the path and into verge area on either side. All verge scrape arisings to be utilised to reform path verges, ensuring finished verge levels remain below path surface levels to allow surface water run-off.</p> <p>Option 2: Assumes no upgrade works, as detailed within Option 1. Generally scrape accumulated mud from the path surface and dispose of arisings well away from path edges. Maintain usable path surface width by regularly cutting back verge vegetation to a width of 1m on either side. Consideration to be given to undertaking a phased programme of maintenance works aimed at carefully scraping back existing verge to expose original path width. Alternative is to apply appropriate herbicide to encroaching ground vegetation and to a width not exceeding original path base width (requires PA1/PA6a certification). Occasional compaction of surface.</p> <p>Drainage: For path construction options 1 and 2: Install drainage letts along the verge to better enable surface water run-off and to alleviate any possible ponding along the edges of the path surface. Locate as required and to a min width of 200mm. Clear inlet and outlet channels to piped culvert and rod out accumulated material within pipe to re-establish full functionality. Apply additional path surface material over culvert to cover exposed pipe (min 75mm depth). Incorporate culvert and associated ditch condition inspection and clearance into annual maintenance schedule.</p> <p>Signage: Option: Install fingerpost signage (to match existing) indicating access to circular route and picnic/recreation area</p>

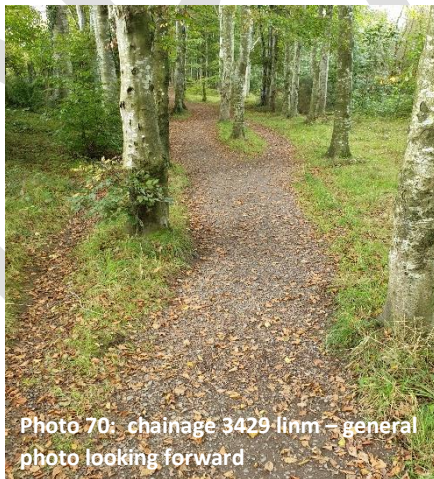
<p>Photo 70: chainage 3429 linm – general photo looking forward</p></div> <p>Generla photo looking forward and showing path route split by trees along centre line of path surface.</p>							
Chainage (linm)	Slope Dir	Grad. (%/deg)	Width (m)	Current Path Condition				Description of Proposed Path Works

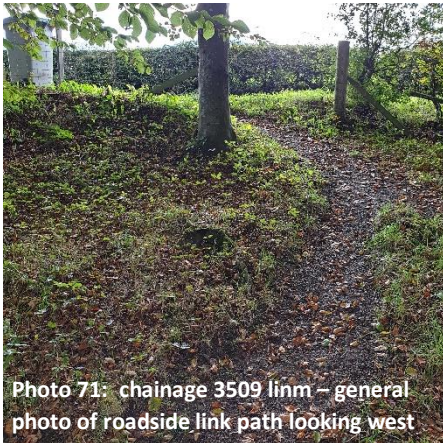
</div> <p>Photo 71: chainage 3509 linm – general photo of roadside link path looking west</p>						
3509		/	/	/	<p>General photo looking left (west) showing unsurfaced and moderately steep link ramp (7 linm) to roadside lay-by on B7020.</p> <div>

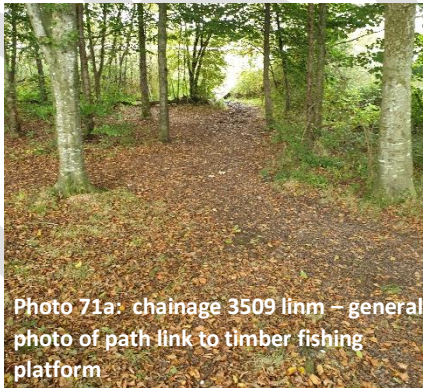
</div> <p>Photo 71a: chainage 3509 linm – general photo of path link to timber fishing platform</p>						
					<p>General photo showing unsurfaced link from surveyed route to timber fishing platform. Link path leads on from link path to lay-by shown in Photo 71.</p>

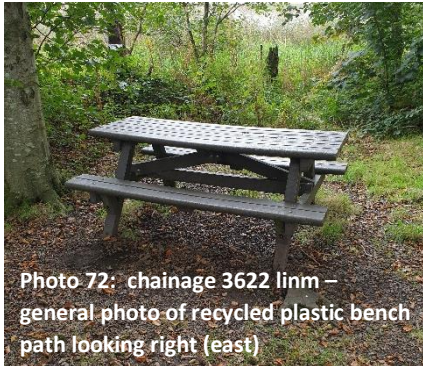
<p>Photo 72: chainage 3622 linm – general photo of recycled plastic bench path looking right (east)</p></div> <p>General photo looking right (east) of recycled plastic picnic table situated on unsurfaced base.</p>						
3622		/	/	/							
3622 - 3748		↔	/	/	<p>Route continues north through woodland and remains parallel to the B7020 carriageway. Surface composed of compacted Type 1 aggregate.</p> <div>

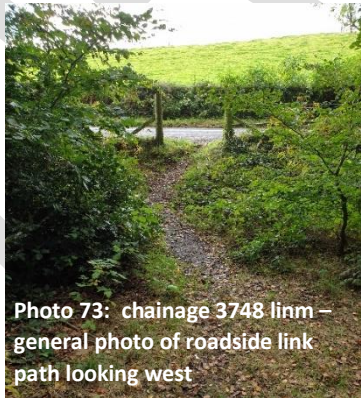
<p>Photo 73: chainage 3748 linm – general photo of roadside link path looking west</p></div> <p>General photo to left (west) showing unsurfaced link path (10 linm) to roadside lay-by on B7020.</p>

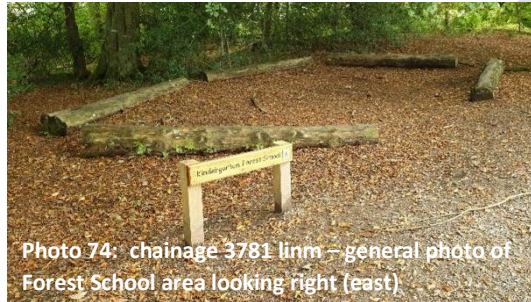
Photo 74: chainage 3781 linm – general photo of Forest School area looking right (east) General photo to right (east) showing area set aside for 'Kindergarten Forest School' activities.		Vegetation Management: Clear any overhanging vegetation, along length of route, to a height of not less than 3.5m from finished path surface (preferred height 3.7m) and any smaller encroaching vegetation not less than 1m from path edges and to a height of 50mm, unless otherwise noted within this technical assessment. All woody vegetation to be cut into manageable lengths and distributed across site within agreed locations. Barriers/Other features: No works required. Path construction and surfacing: Option 1: Carefully scrape back all encroaching verge vegetation to expose full width of previously installed path (estimated to be a minimum of 1.5m) and upgrade surface to Drawing CL/UPU/CLLCT/001. Construct path levels to max 1:40 camber throughout to allow any surface water run-off to be discharged off the path and into verge area on either side. All verge scrape arisings to be utilised to reform path verges, ensuring finished verge levels remain below path surface levels to allow surface water run-off. Option 2: Assumes no upgrade works, as detailed within Option 1. Generally scrape accumulated mud from the path surface and dispose of arisings well away from path edges. Maintain usable path surface width by regularly cutting back verge vegetation to a width of 1m on either side. Consideration to be given to undertaking a phased programme of maintenance works aimed at carefully scraping back existing verge to expose original path width. Alternative is to apply appropriate herbicide to encroaching ground vegetation and to a width not exceeding original path base width (requires PA1/PA6a certification). Occasional compaction of surface. Link Path: Install new path from road to timber platform to general detail contained within Drawing No. CL/UPU/CLLCT/001 but ensuring min 100mm depth of base material. Drainage: For path construction options 1 and 2: Install drainage letts along the verge to better enable surface water run-off and to alleviate any possible ponding along the edges of the path surface. Locate as required and to a min width of 200mm. Signage: No works required

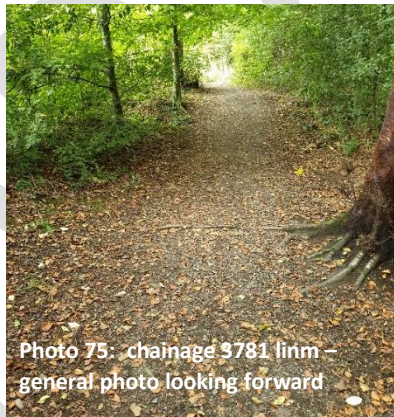
Photo 75: chainage 3781 linm – general photo looking forward General photo looking forward.					
3781 - 3808	↔	/	<1.6	Route continues north through woodland and remains parallel to the B7020 carriageway. Surface composed of compacted Type 1 aggregate. 300mm twinwall piped culvert located at chainage 3791 linm taking water from left to right under path. Culvert in good operating condition.					
Chainage (linm)	Slope Dir	Grad. (%/deg)	Width (m)	Current Path Condition		Description of Proposed Path Works

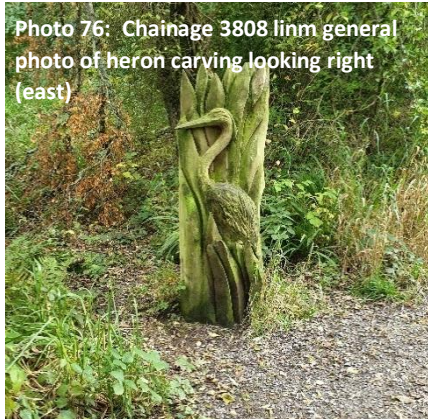
</div> <div>General photo showing wooden carved heron to right (east) of path.</div>	<div>Vegetation Management: Clear any overhanging vegetation, along length of route, to a height of not less than 3.5m from finished path surface (preferred height 3.7m) and any smaller encroaching vegetation not less than 1m from path edges and to a height of 50mm, unless otherwise noted within this technical assessment. All woody vegetation to be cut into manageable lengths and distributed across site within agreed locations.</div> <div>Barriers/Other features: No works required.</div> <div>Path construction and surfacing: Option 1: Carefully scrape back all encroaching verge vegetation to expose full width of previously installed path (estimated to be a minimum of 1.5m) and upgrade surface to Drawing CL/UPU/CLLCT/001. Construct path levels to max 1:40 camber throughout to allow any surface water run-off to be discharged off the path and into verge area on either side. All verge scrape arisings to be utilised to reform path verges, ensuring finished verge levels remain below path surface levels to allow surface water run-off. Option 2: Assumes no upgrade works, as detailed within Option 1. Generally scrape accumulated mud from the path surface and dispose of arisings well away from path edges. Maintain usable path surface width by regularly cutting back verge vegetation to a width of 1m on either side. Consideration to be given to undertaking a phased programme of maintenance works aimed at carefully scraping back existing verge to expose original path width. Alternative is to apply appropriate herbicide to encroaching ground vegetation and to a width not exceeding original path base width (requires PA1/PA6a certification). Occasional compaction of surface.</div> <div>Link Path: Install new path from road to timber platform to general detail contained within Drawing No. CL/UPU/CLLCT/001 but ensuring min 100mm depth of base material.</div> <div>Drainage: For path construction options 1 and 2: Install drainage letts along the verge to better enable surface water run-off and to alleviate any possible ponding along the edges of the path surface. Locate as required and to a min width of 200mm.</div> <div>Signage: Option: Install fingerpost signage indicating access to circular route and timber fishing platform</div>

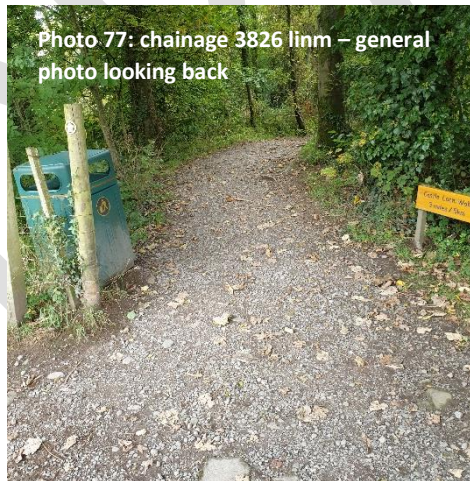
3808 - 3826	↔	/	<1.6	Route continues north through woodland and remains parallel to the B7020 carriageway. Surface composed of compacted Type 1 aggregate.					
3826	/	/	/	<div><div>Photo 77: chainage 3826 linm – general photo looking back</div>

</div> <div>Woodland section of the route ends and exists onto access road to Bowling Club.</div>					
Chainage (linm)	Slope Dir	Grad. (%/deg)	Width (m)	Current Path Condition	Description of Proposed Path Works

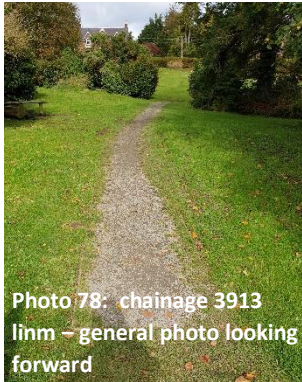
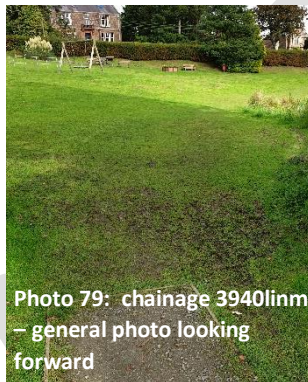
</div></div> <p>General photo showing edge of carpark and start of timber edged aggregate path at chainage 3913 linm (photo 78). Path measured at 1.0m wide. Timber edged path ends at chainage 3940 linm (photo 79) and enters open amenity grass area with play equipment. Transition between aggregate path and amenity grass area subject to heavy wear and potential waterlogging/mud.</p>					
3940 - 4062	/	/	/	<div><div>

Vegetation Management: Clear any overhanging vegetation, along length of route, to a height of not less than 3.5m from finished path surface (preferred height 3.7m) and any smaller encroaching vegetation not less than 1m from path edges and to a height of 50mm, unless otherwise noted within this technical assessment. All woody vegetation to be cut into manageable lengths and distributed across site within agreed locations.						Barriers/Other features: No works required.			
Path construction and surfacing: Option 1: Carefully scrape back all encroaching verge vegetation to expose full width of previously installed path (estimated to be a minimum of 1.5m) and upgrade surface to Drawing CL/UPU/CLLCT/001. Construct path levels to max 1:40 camber throughout to allow any surface water run-off to be discharged off the path and into verge area on either side. All verge scrape arisings to be utilised to reform path verges, ensuring finished verge levels remain below path surface levels to allow surface water run-off.						Option 2: Assumes no upgrade works, as detailed within Option 1. Generally scrape accumulated mud from the path surface and dispose of arisings well away from path edges. Maintain usable path surface width by regularly cutting back verge vegetation to a width of 1m on either side. Consideration to be given to undertaking a phased programme of maintenance works aimed at carefully scraping back existing verge to expose original path width. Alternative is to apply appropriate herbicide to encroaching ground vegetation and to a width not exceeding original path base width (requires PA1/PA6a certification). Occasional compaction of surface.

Drainage: For path construction options 1 and 2: Install drainage letts along the verge to better enable surface water run-off and to alleviate any possible ponding along the edges of the path surface. Locate as required and to a min width of 200mm.						Signage: Option: Install fingerpost signage indicating access to circular route and timber fishing platform			
Chainage (linm)	Slope Dir	Grad. (%/deg)	Width (m)	Current Path Condition				Description of Proposed Path Works

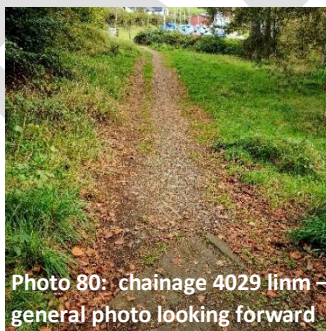
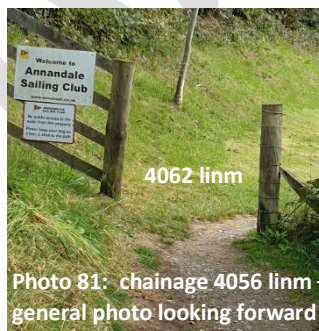
</div></div> <p>Route traverses open amenity grass area with play equipment to left. Route undefined and contours across slope which falls from left to right. General photos taken at chainage 4029 lin m and 4056 linm looking forward.</p>

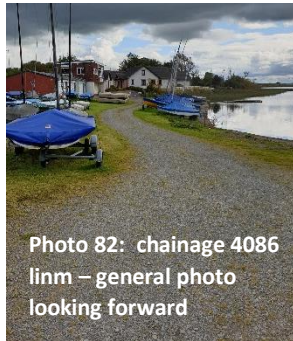
<p>Photo 82: chainage 4086 linm – general photo looking forward</p></div> <div>

<p>Photo 82a: chainage 4086 linm – general photo looking back</p></div> <p>Route passes through gap in fence at chainage 4062 linm (shown in photos 81 & 82a). Gap measured at 950mm wide.</p> <p>Route then passes across Annandale Sailing Club hard standing area and to front of clubhouse (general photos taken at chainage 4086 looking forward '82' and back '82a') before rising up short incline road that serves as access road. Route joins pavement off A907 before turning right (South East).</p>	<p>Vegetation Management: No works required.</p> <p>Barriers/Other features: No works required.</p> <p>Path construction and surfacing: No works required.</p> <p>Drainage: For path construction options 1 and 2: Install drainage letts along the verge to better enable surface water run-off and to alleviate any possible ponding along the edges of the path surface. Locate as required and to a min width of 200mm.</p> <p>Signage: Keep vegetation clear of existing roundels at entrance to woodland edge section of the route</p>

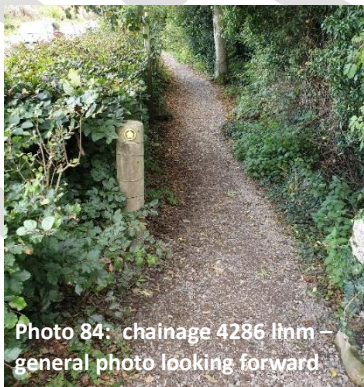
<p>Photo 84: chainage 4286 linm – general photo looking forward</p></div> <p>General photo looking forward where roadside footway turns right and away from roadside, down gentle ramp and into woodland edge, running parallel to A907 and roadside hedge.</p>					
Chainage (linm)	Slope Dir	Grad. (%/deg)	Width (m)	Current Path Condition		Description of Proposed Path Works

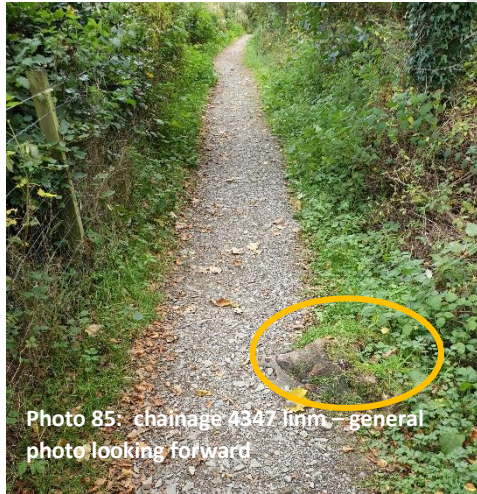
<p>Photo 85: chainage 4347 linm – general photo looking forward</p>					
4347 - 4587		↔	/	<1.5	General photo looking forward and showing tree stump (circled) encroaching into path and narrowing effective width. Route continues south, running parallel to A907 on left. Path width varies along this section from 0.9 – 1.5m. Path base is composed of compacted Type 1 aggregate with no surface blinding/layer.					
Chainage (linm)	Slope Dir	Grad. (%/deg)	Width (m)	Current Path Condition			Description of Proposed Path Works

Vegetation Management:
Clear any overhanging vegetation, along length of route, to a height of not less than 3.5m from finished path surface (preferred height 3.7m) and any smaller encroaching vegetation not less than 1m from path edges and to a height of 50mm, unless otherwise noted within this technical assessment.
All woody vegetation to be cut into manageable lengths and distributed across site within agreed locations.

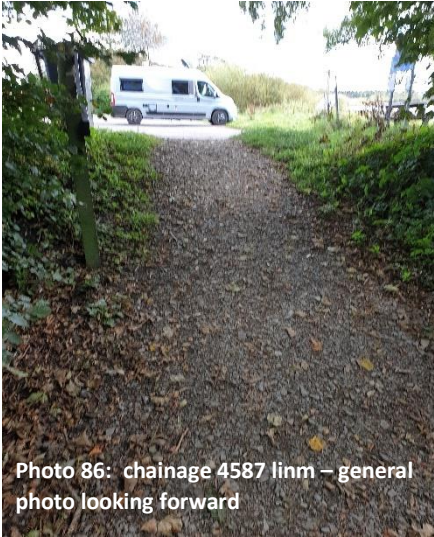
<p>Photo 86: chainage 4587 linm – general photo looking forward</p> <p>General photo looking forward at chainage 4587 linm and showing moderate to steep ramp leading up to Castle Loch carparking area and end of surveyed route at chainage 4595 linm. Path base remains as compacted Type 1 aggregate with no surface blinding/layer.</p> </div> <div>

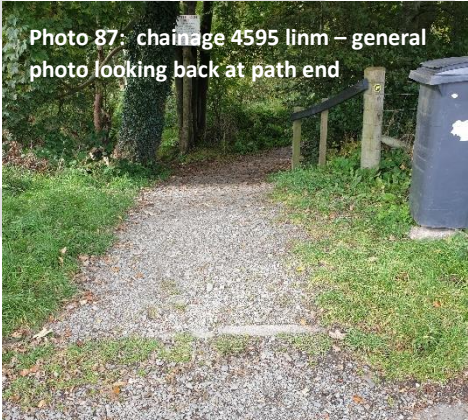
<p>Photo 87: chainage 4595 linm – general photo looking back at path end</p> <p>General photo showing end of path looking back.</p> </div>					<p>Vegetation Management: Clear any overhanging vegetation, along length of route, to a height of not less than 3.5m from finished path surface (preferred height 3.7m) and any smaller encroaching vegetation not less than 1m from path edges and to a height of 50mm, unless otherwise noted within this technical assessment. All woody vegetation to be cut into manageable lengths and distributed across site within agreed locations.</p> <p>Barriers/Other features: Handrail: Option to install single handrail on access ramp to circular walk as a general aid to path users.</p> <p>Path construction and surfacing: Option 1: Carefully scrape back all encroaching verge vegetation to expose full width of previously installed path (estimated to be a minimum of 1.5m) and upgrade surface to Drawing CL/UPU/CLLCT/001. Construct path levels to max 1:40 camber throughout to allow any surface water run-off to be discharged off the path and into verge area on either side. All verge scrape arisings to be utilised to reform path verges, ensuring finished verge levels remain below path surface levels to allow surface water run-off.</p> <p>Option 2: Assumes no upgrade works, as detailed within Option 1. Generally scrape accumulated mud from the path surface and dispose of arisings well away from path edges. Maintain usable path surface width by regularly cutting back verge vegetation to a width of 1m on either side. Consideration to be given to undertaking a phased programme of maintenance works aimed at carefully scraping back existing verge to expose original path width. Alternative is to apply appropriate herbicide to encroaching ground vegetation and to a width not exceeding original path base width (requires PA1/PA6a certification). Occasional compaction of surface.</p> <p>Drainage: For path construction options 1 and 2: Install drainage letts along the verge to better enable surface water run-off and to alleviate any possible ponding along the edges of the path surface. Locate as required and to a min width of 200mm.</p> <p>Signage: Option: Install fingerpost signage indicating access to circular route</p>
